**MULTI-MODAL INTERSECTIONS:  
RESOLVING CONFLICTS  
BETWEEN TRAINS, MOTOR  
VEHICLES, BICYCLISTS AND  
PEDESTRIANS**

**Final Report**

**SPR 794**

Oregon Department of Transportation

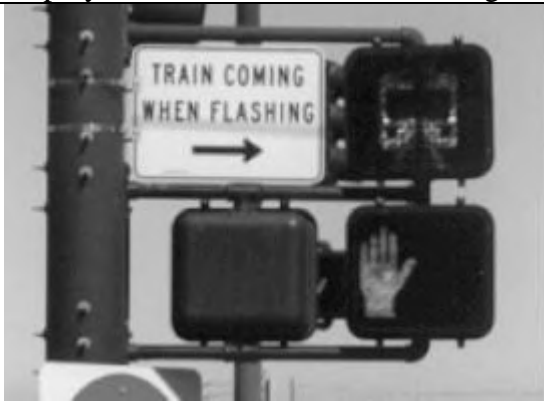
(FHWA, 2007)
Vehicle-Activated Strobe Light	<p>A strong light that is activated by an oncoming vehicle. Intended for use at passive highway-railroad grade crossings, with the purpose of gaining the driver's attention and directing their attention to the warning signs (Fambro &amp; Noyce, 1997). Positive experience in rural Texas. Cost \$5,000 per light (1997-\$s), maintenance is higher than passive signs (Fambro &amp; Noyce, 1997).</p>
Automatic Swing Gates	<p>As manual swing gates, but operated as standard automatic gates. Usually employed in combination with fencing.</p>
Train Coming Icon

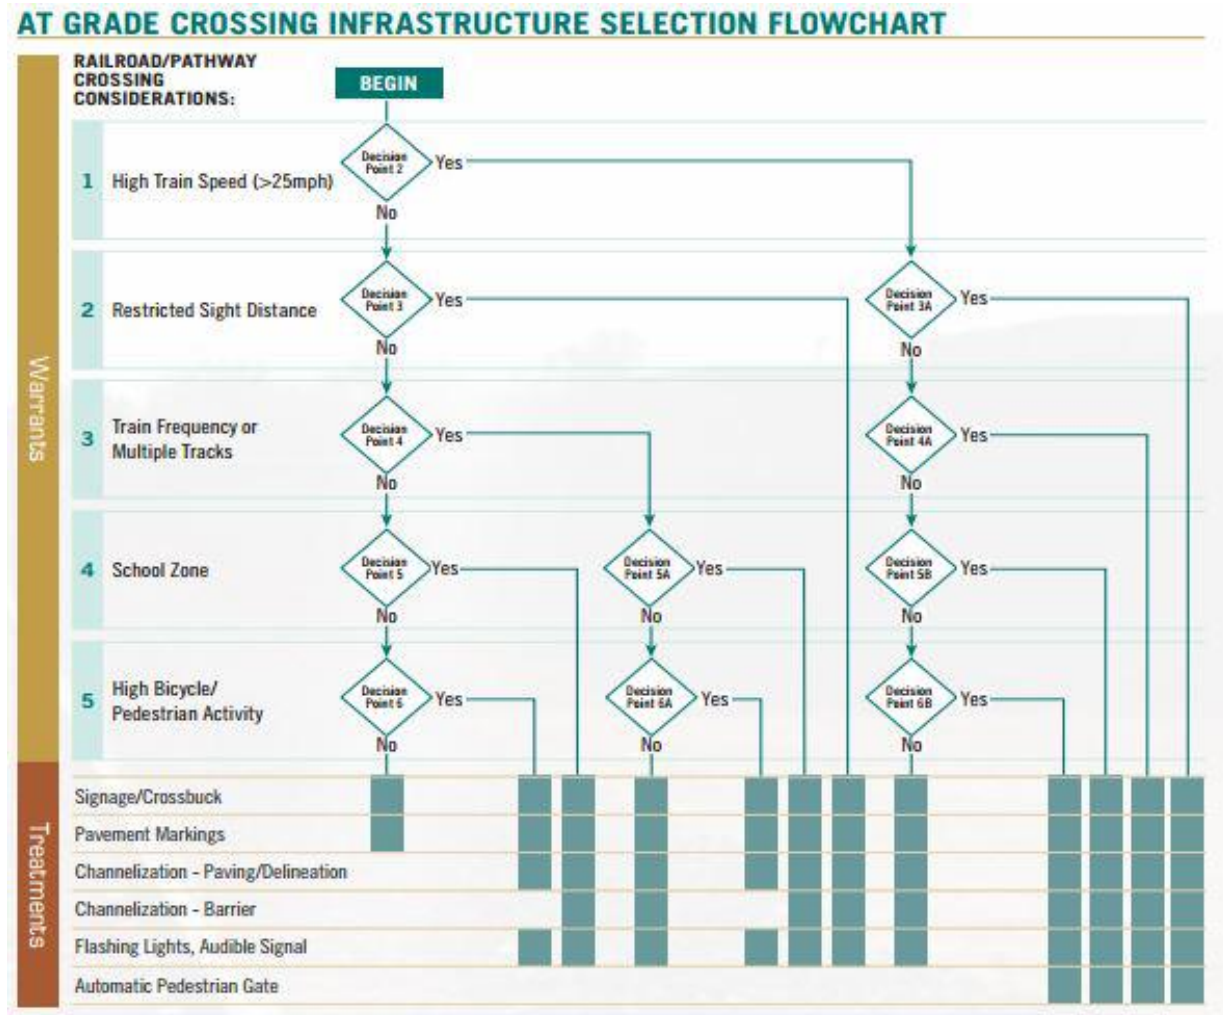
The Arizona-based regional planning organization Maricopa Association of Governments published a report in 2014 with recommendations for improving safety for pedestrians and bikes at crossings. With the report, they developed a flowchart to decide which treatments should be used at an at-grade crossing. The flowchart is shown in full below.

**Figure 2.1: At-grade crossing infrastructure selection flowchart (MAG, 2014)**

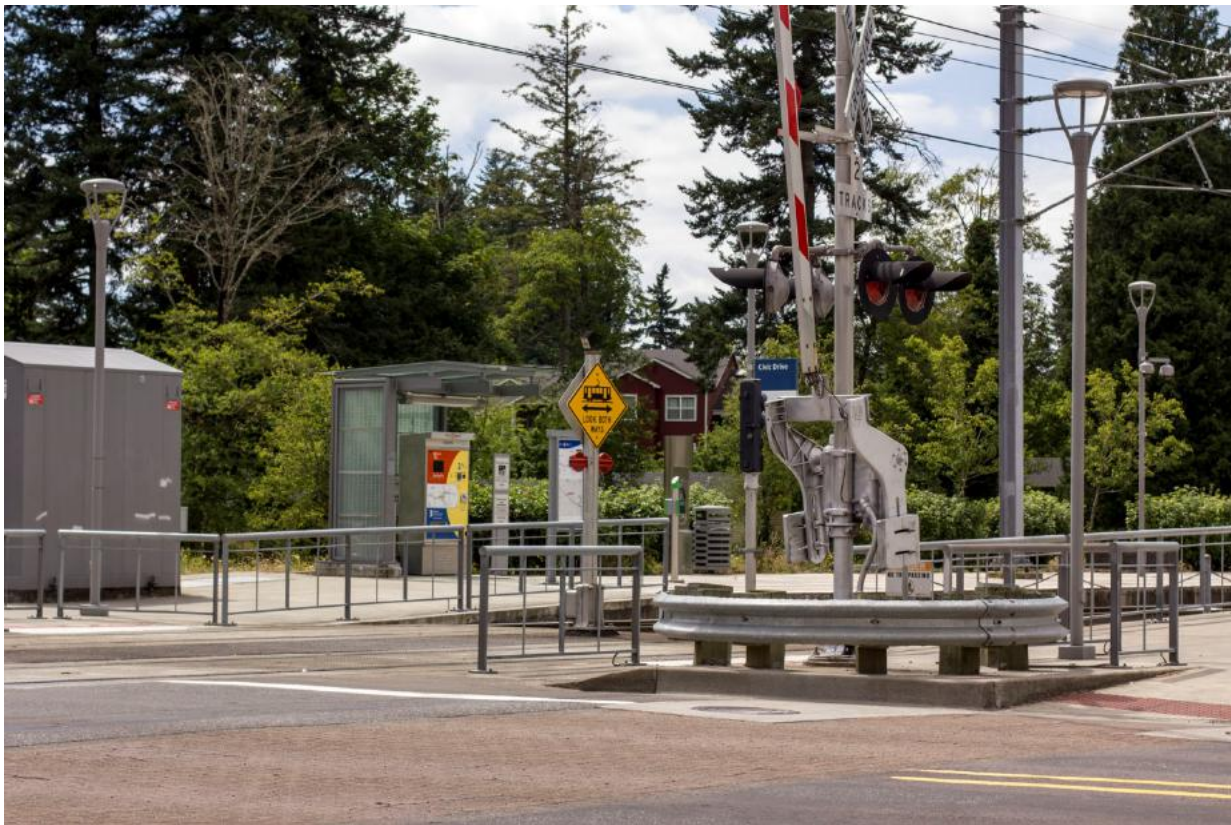
The current treatments at this site includes a variety of active and passive equipment. The crossing is fitted with active gates, lights and bells. Signage includes a 2-tracks cross buck, a sign telling pedestrians to look both ways, and signs pointing out the sites of the pedestrian crosswalk field. Underneath the pedestrian crosswalk sign, which can be illuminated with the help of a push button (Rectangular Rapid Flash Beacon), a sign telling drivers to not stop on tracks is installed. Where the tracks can be crossed, channelization has been installed to make pedestrians look both ways. The Z crossing enables the pedestrian and the train operator to be in nearly constant eye contact during the crossing movement. The use of a median refuge island separates the crossing into two movements. These are accompanied by an active mini pedestrian light and bell between the two sets of tracks, and a sign telling pedestrians to look both ways. There is a stop line for road users and no median. The pedestrian crosswalk zone is furthermore marked using a different type of surfacing.

**Figure 3.2: Active and passive treatments, and the adjacent light rail station.**

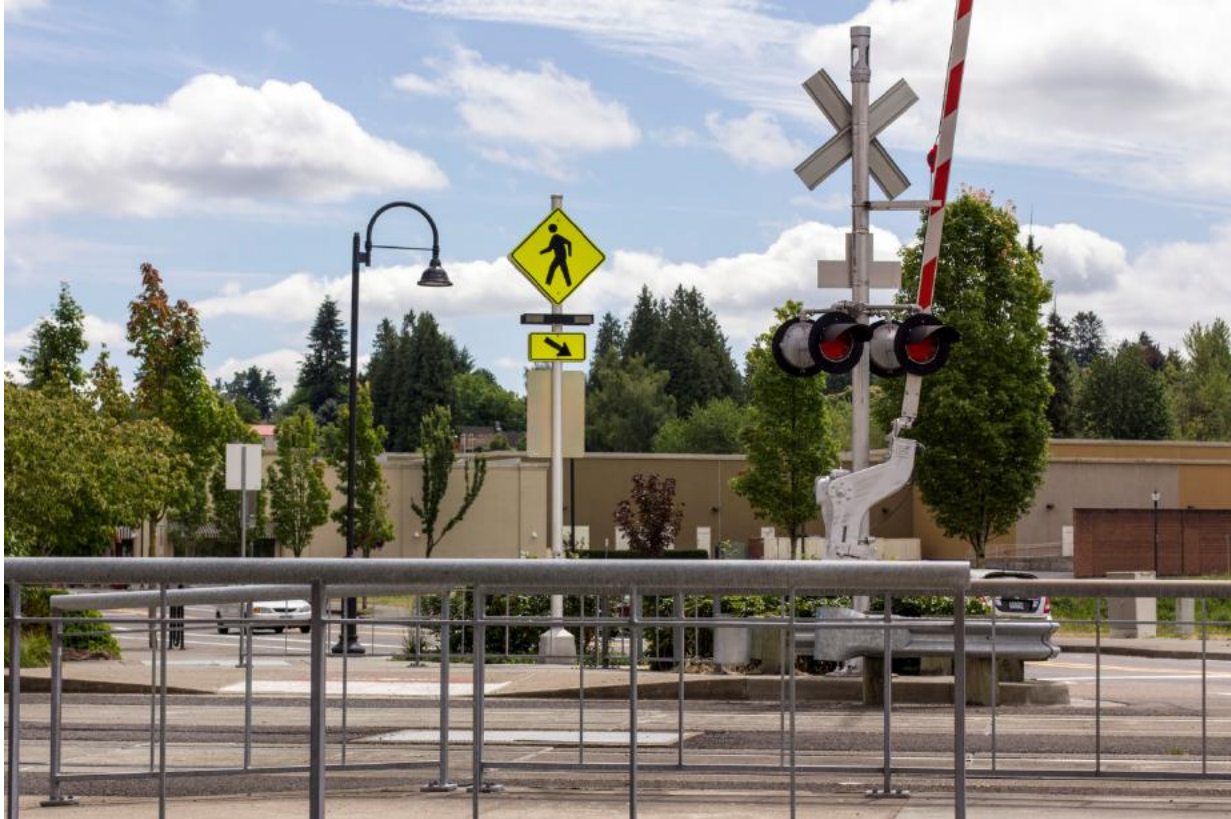
**Figure 3.3: Active and passive treatments at the NW Civic Dr crossing**

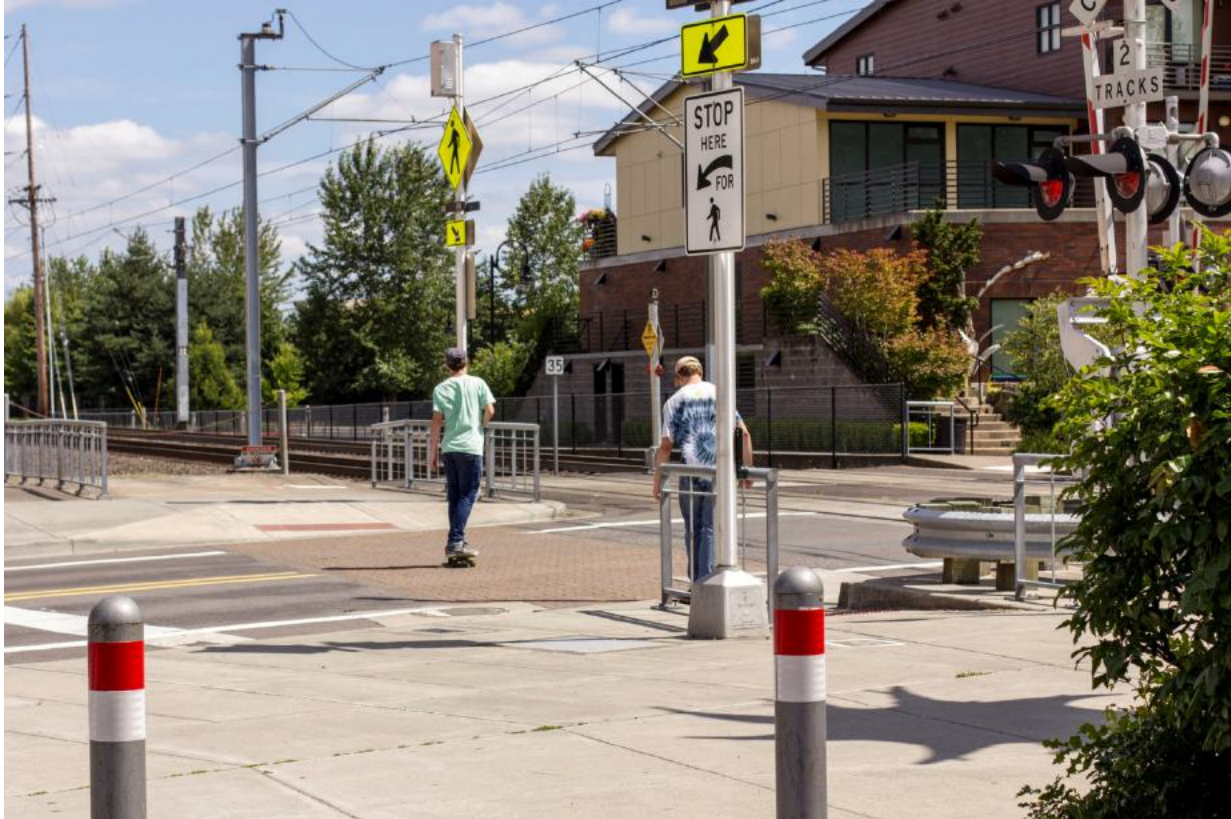
This location allows pedestrians to cross adjacent to the tracks on both sides. As one side is equipped with a trail, which is where most of the crossing take place, though there's also quite a few crossings made adjacent to the tracks, by people walking to and from the station. Both crosswalks are marked with tactile surfaces, different crossing surface, and pedestrian-activated push buttons (RRFBs) that can be enabled by users wishing to cross adjacent to the tracks. The crosswalk fields are marked by signage as seen in Figure 3.4.

**Figure 3.4: Pedestrian facilities found at both sides of the crossing**

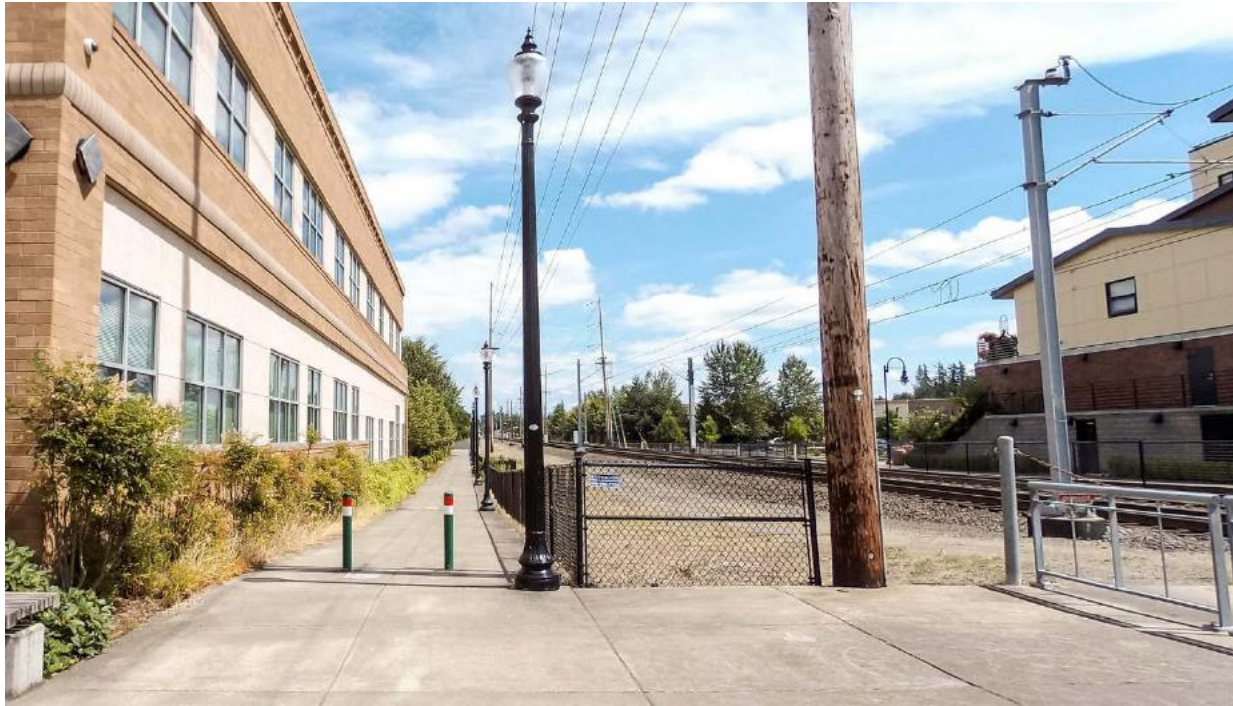
This location has several different forms of facilities for bike and pedestrian traffic. There is a multi-use trail running adjacent to the light rail tracks, called the Max Rail Trail. Though there is a trail running across the road, it did not appear that the two trails were connected or used for their connection, and few users were seen moving from one side of the trail to the other. Both sides of the road are equipped with sidewalks and the road and tracks can be crossed four ways. There is passive pedestrian management across the tracks, and pedestrian-activated push buttons to cross the road next to the track. Both sides of the road are equipped with bike lanes.

**Figure 3.5: Multiuse trail**

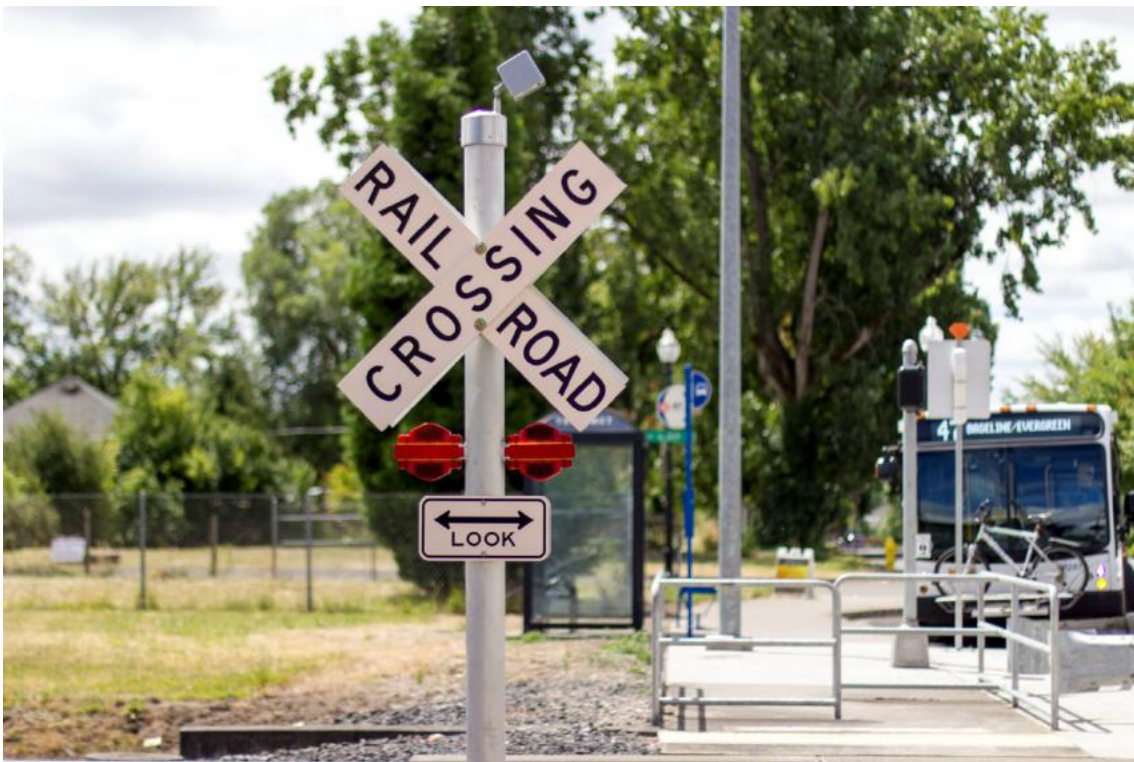
**Figure 3.12: Active TriMet Style Pedestrian Flashers (TMPF's) and pedestrian fencing**

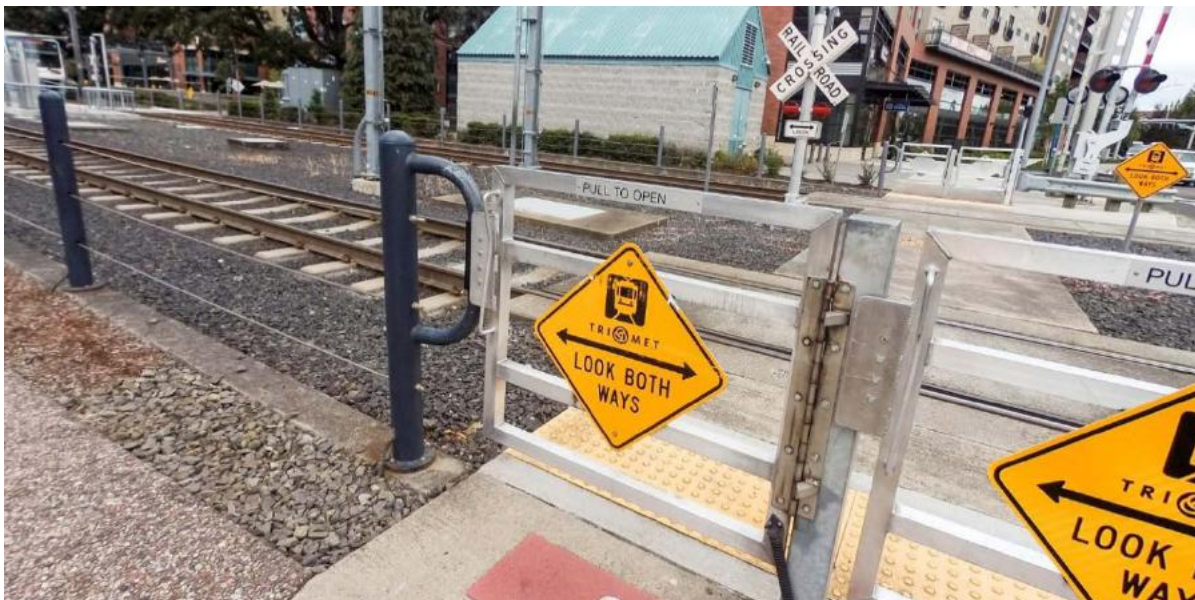
**Figure 3.14: Passive gates close off both sides of the crossing closets to the light rail**

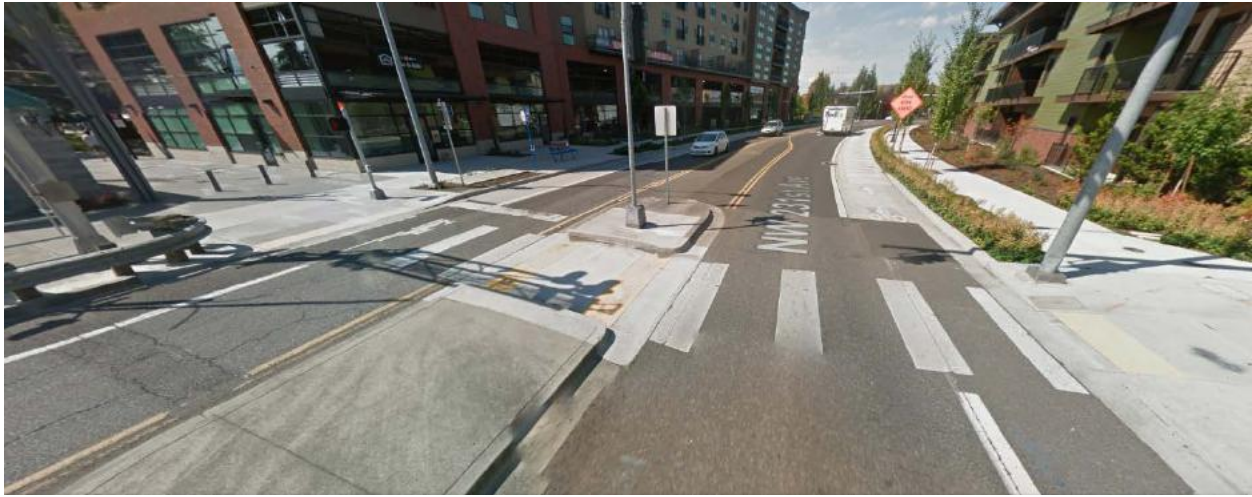
The adjacent path is primarily used by pedestrians, though a few bikes were also observed. The trailhead is marked by bollards on one side, the one leading from the station and the plaza, but not on the other side. There are pedestrian crossings on both sides of the street and they are both marked with stripes and yellow tactile warning plates.

Both crosswalks have refuge islands in the middle, and are signalized with a button activated light signal.

**Figure 3.15: Highway/Path Crossing (Google, 2016)**

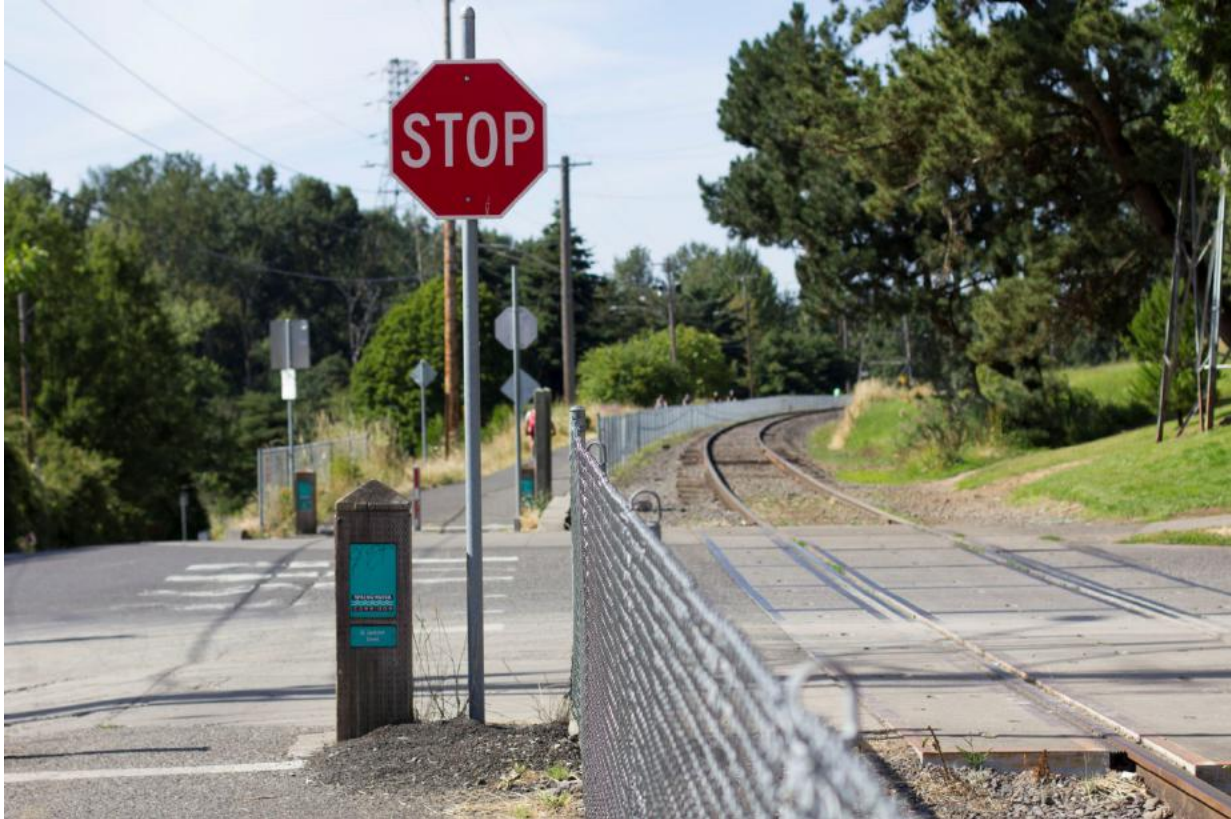
The multi-use trailheads are both equipped with stop signs of a design specified for use on trails which are placed lower and are smaller than a standard sign, and designed according to MUTCD Section 8D and Part 9. Both trailheads are equipped with a stop line and both have one bollard, which is placed to show the two-way nature of the multi-use path. The crossing is marked.

**Figure 3.21: There are stop signs installed at all approaches and for all road users**

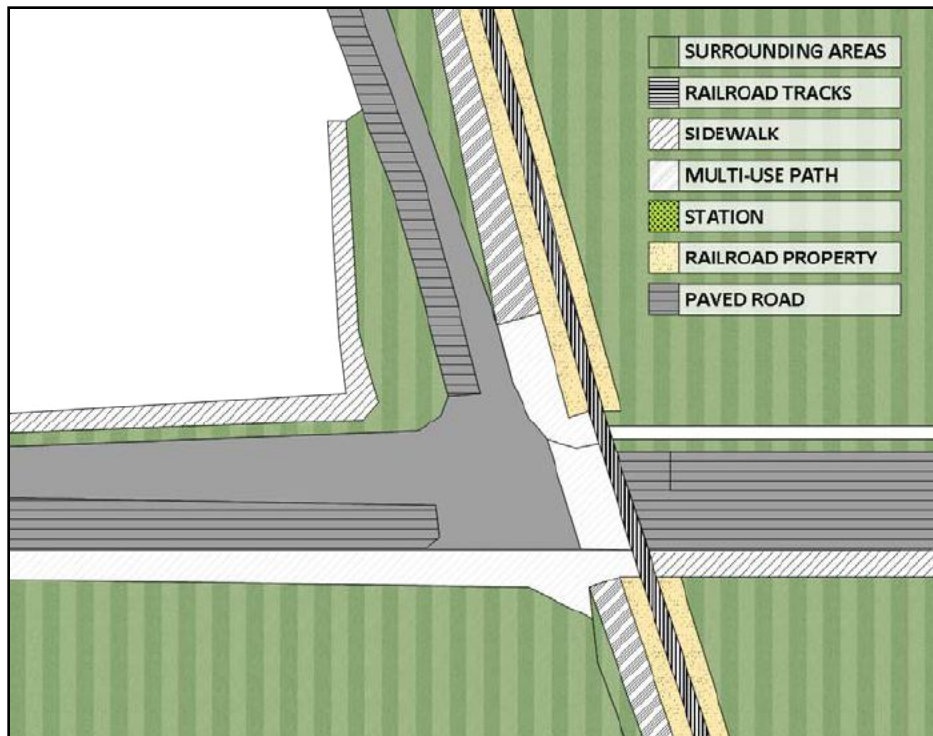
**Figure 3.22: Diagram of SE Spokane St.**

A simplified diagram of SE Spokane St. is included below to exemplify the dynamic movements of road and path users at this crossing.

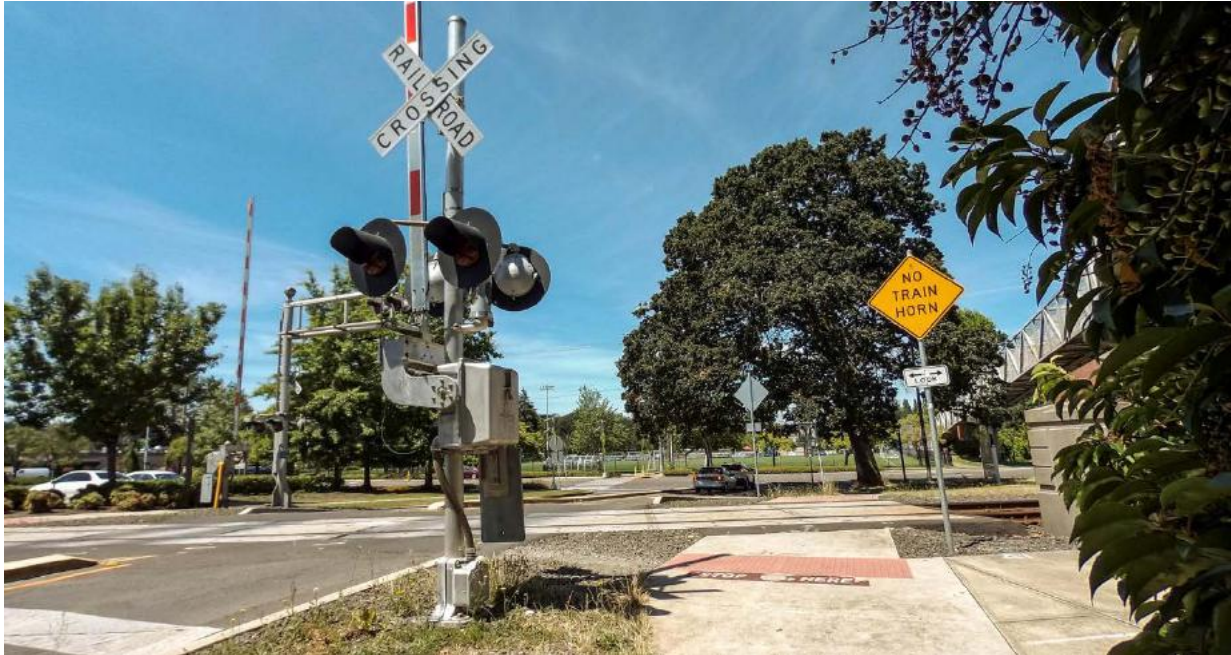
**Figure 3.27: Active and passive treatments at the SE Mill St Crossing**

This crossing is equipped with active treatments in the form of gates, lights and bells. It also has several other treatments including cross bucks, pavement markings and a stop lines. For pedestrians, there are only passive treatments, except for the audible device. These include tactile markings, a painted warning mark on the sidewalk and a sign “NO TRAIN HORN” reminding pedestrians that the train at this location does not use its horn and that it can be coming from both sides. This is due to the crossing being in a Quiet Zone. The road is equipped with a median, potentially to discourage road users to drive around the gates.

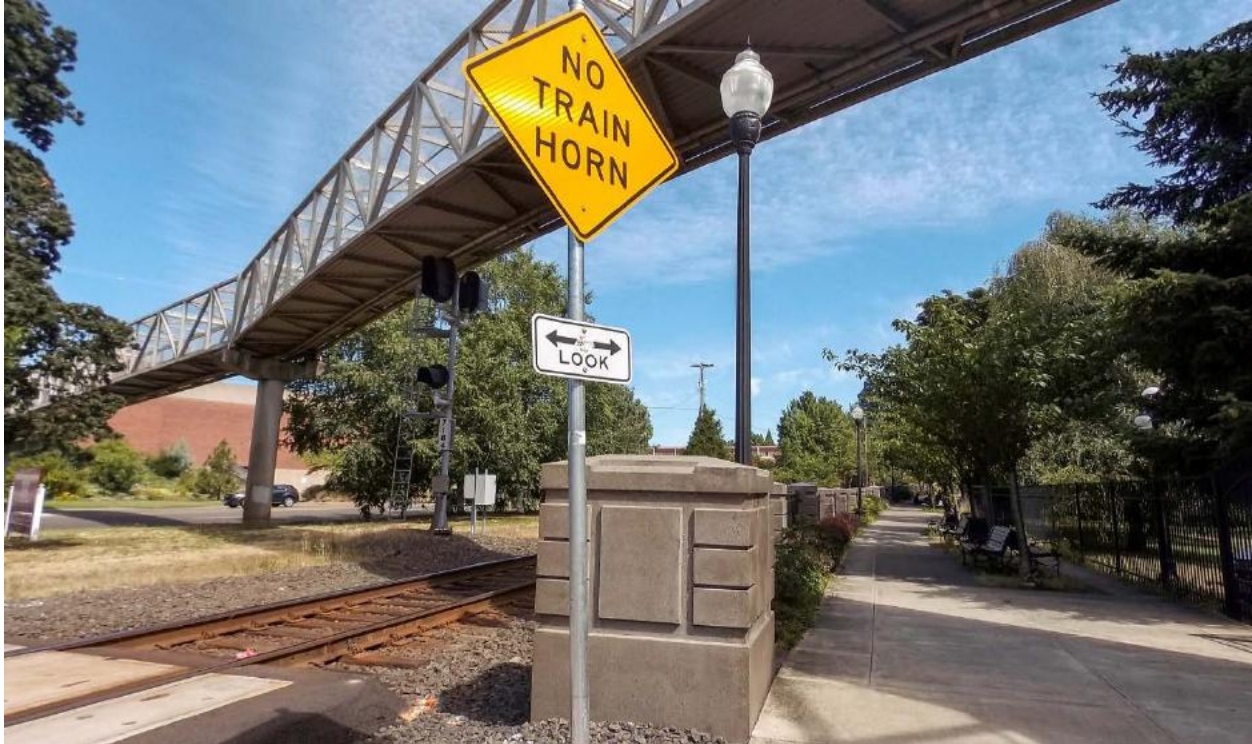
The crossing at SE Mill St is equipped with a variety of pedestrian and bike facilities. First, it has a trail coming from one side, which seems to be more geared towards pedestrians, though it is categorized as a Promenade, where motor vehicles are legally permitted to share with bicyclists and pedestrians. The trail does not continue onto the other side. There is nothing facilitating crossing the road adjacent to the railroad tracks, but instead it is designed so that people continue down the sidewalk to the next intersection, cross there, before walking back up on the other side.

**Figure 3.28: The sight from the pedestrian stop line at the end of the trail**

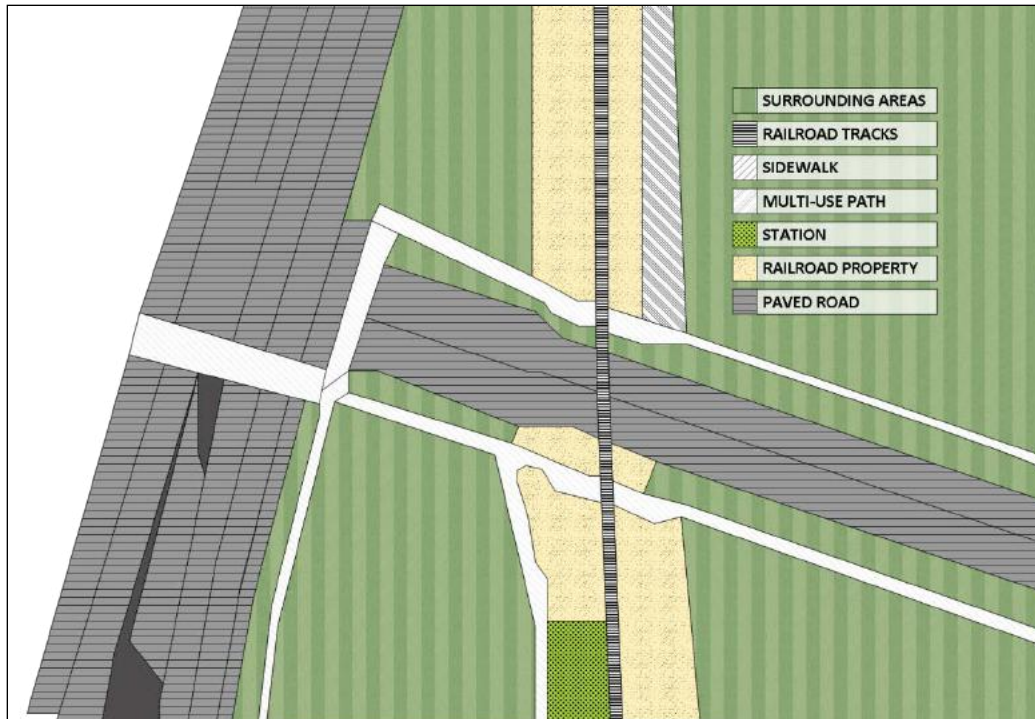
**Figure 3.29: Diagram of SE Mill St**

A simplified diagram of SE Mill St is included below to exemplify the dynamic movements of road and path users at this crossing.

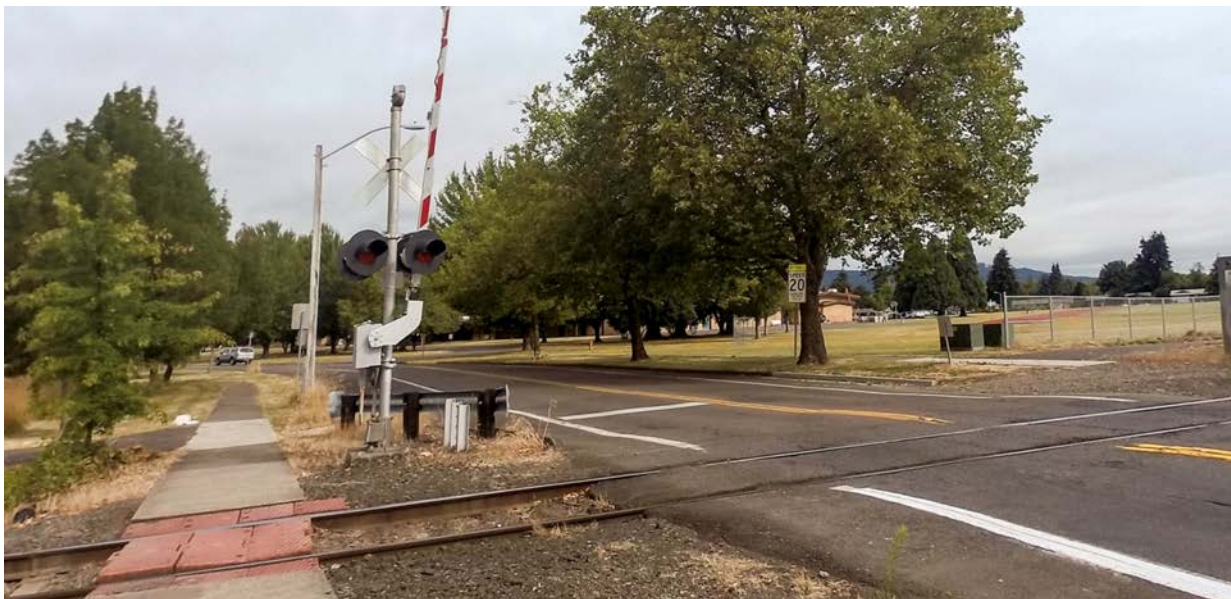
**Figure 3.33: The active treatments at NE Conifer Blvd (School marked in yellow)**

This location is equipped with both active and passive treatments. This include active gates, lights and bells and a railroad warning sign, W10-1 cross bucks and a stop line for vehicular users.

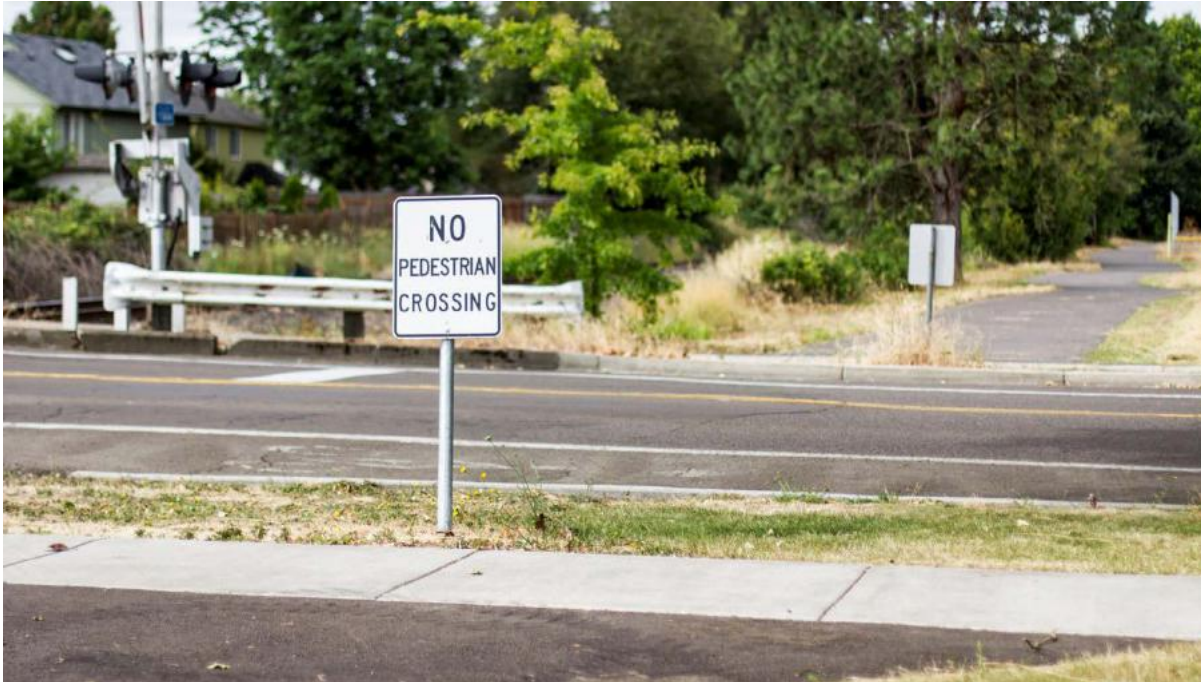
**Figure 3.34: The” No Pedestrian Crossing”-sign placed at both trailheads.**

At the end of both trailheads, a “No pedestrian crossing”-sign facing people who are approaching the crossing from the path, is placed as seen in Figure 3.34. Under ORS 810.080 the authority can: “(...) prohibit [] pedestrians from crossing a roadway where a crosswalk has been closed by placing and maintaining signs giving notice of closure. prohibit [] pedestrians from crossing a highway at any place other than within a marked or unmarked crosswalk”, why crossing the road at such a location is considered prohibited.

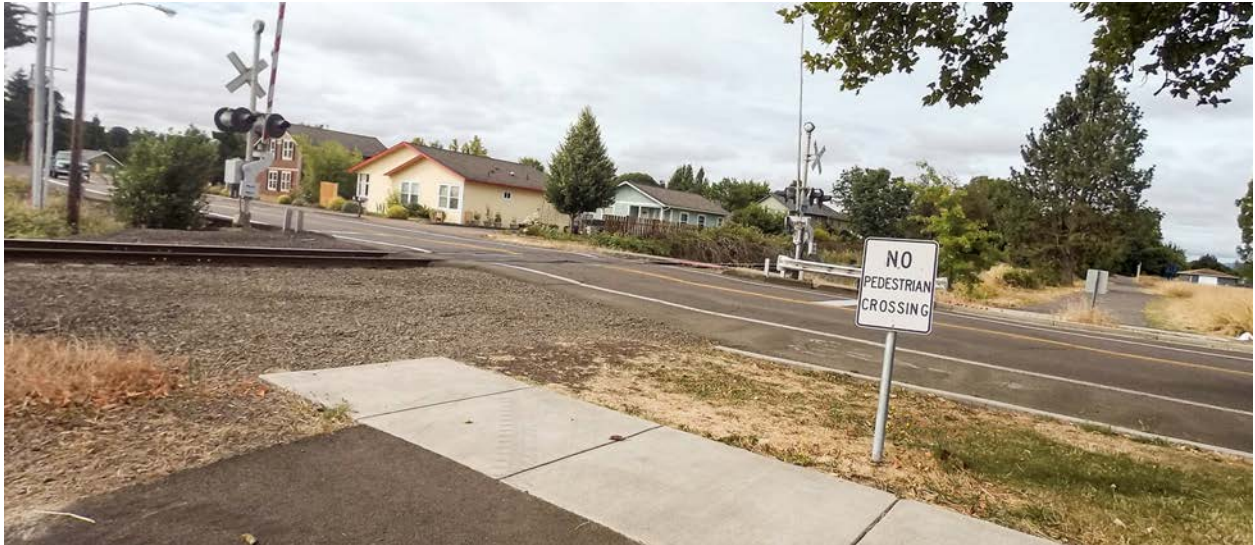
**Figure 3.35: The sidewalk suddenly stops at the tracks**

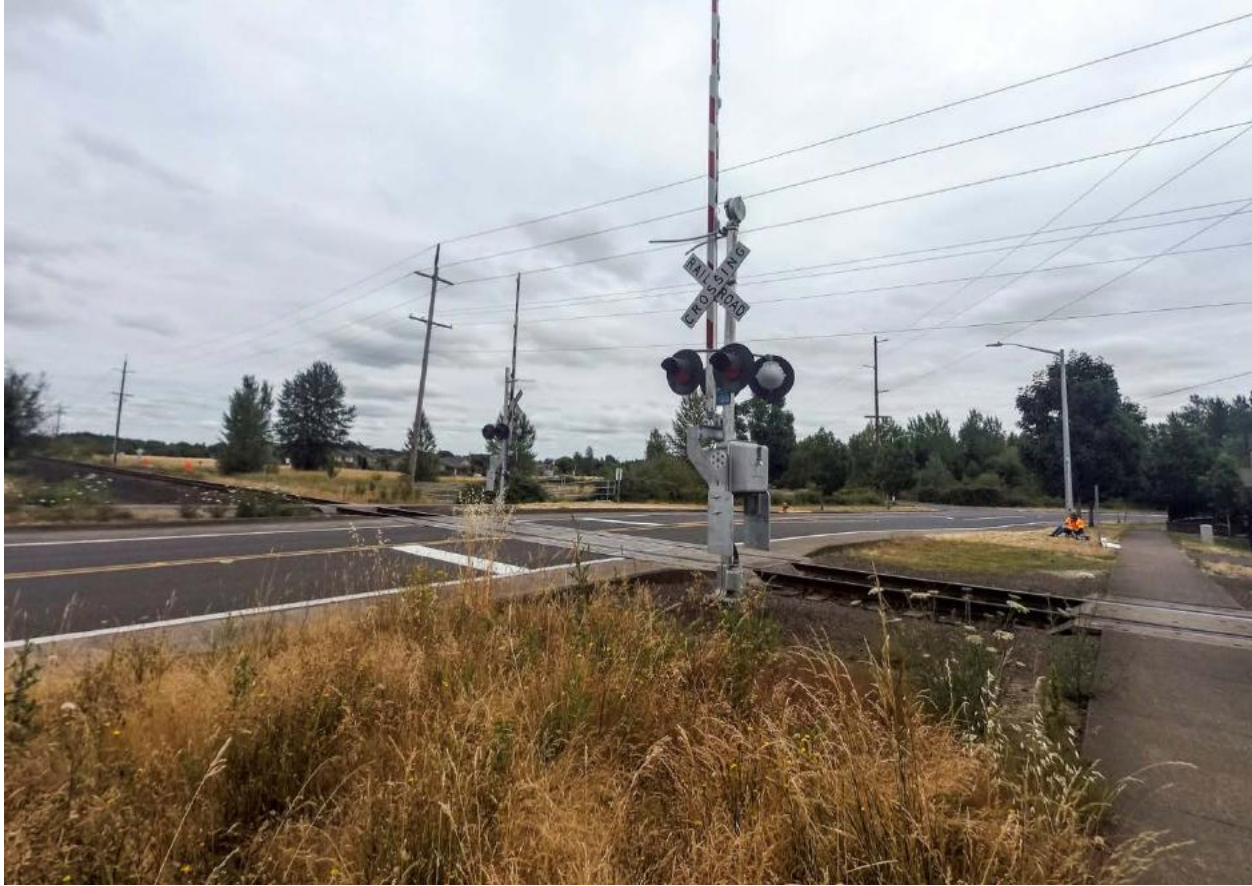
The treatments at this location are very like the treatments found at the NE Conifer Blvd crossing. There are active treatments, including gates, lights and bells. The crossing is signaled with cross bucks, railroad road markings and a stop line.

**Figure 3.40: Active treatments at the NE Walnut Blvd crossing**

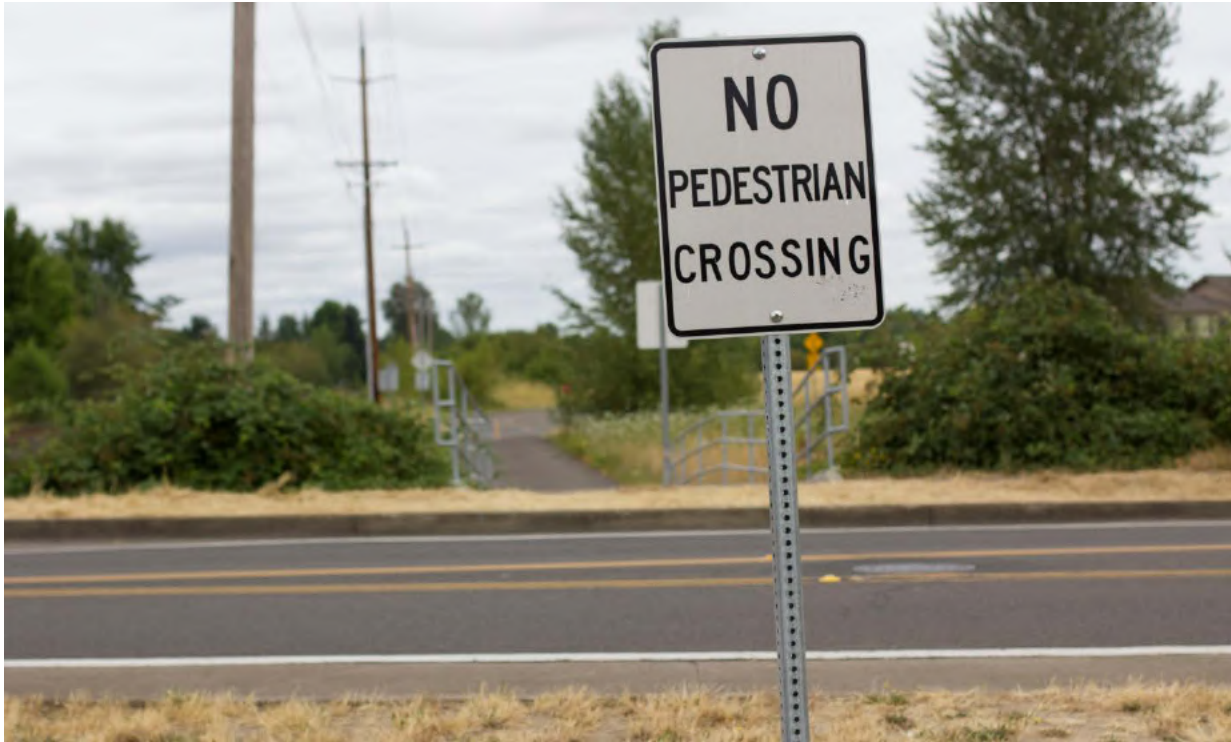
**Figure 3.41: At NE Walnut Blvd it is prohibited under ORS 810.080 to cross the road between the two trailheads**

The purpose of the trail at this location is primarily to connect residents of the area to other residential areas and provide a through cut for users. It is possible to cross the tracks on both sides of the road. East of the tracks, and south of Walnut Blvd, a road named NE Seavy Ave functions as a trail. However, at the crossing, it is designed just as NE Conifer Rd, as seen in Figure 3.41, and is marked with the use of a “No Pedestrian Crossing”-sign that is placed at both entrances to the trail. Under ORS 810.080 the authority can: “(...) prohibit [] pedestrians from crossing a roadway where a crosswalk has been closed by placing and maintaining signs giving notice of closure.

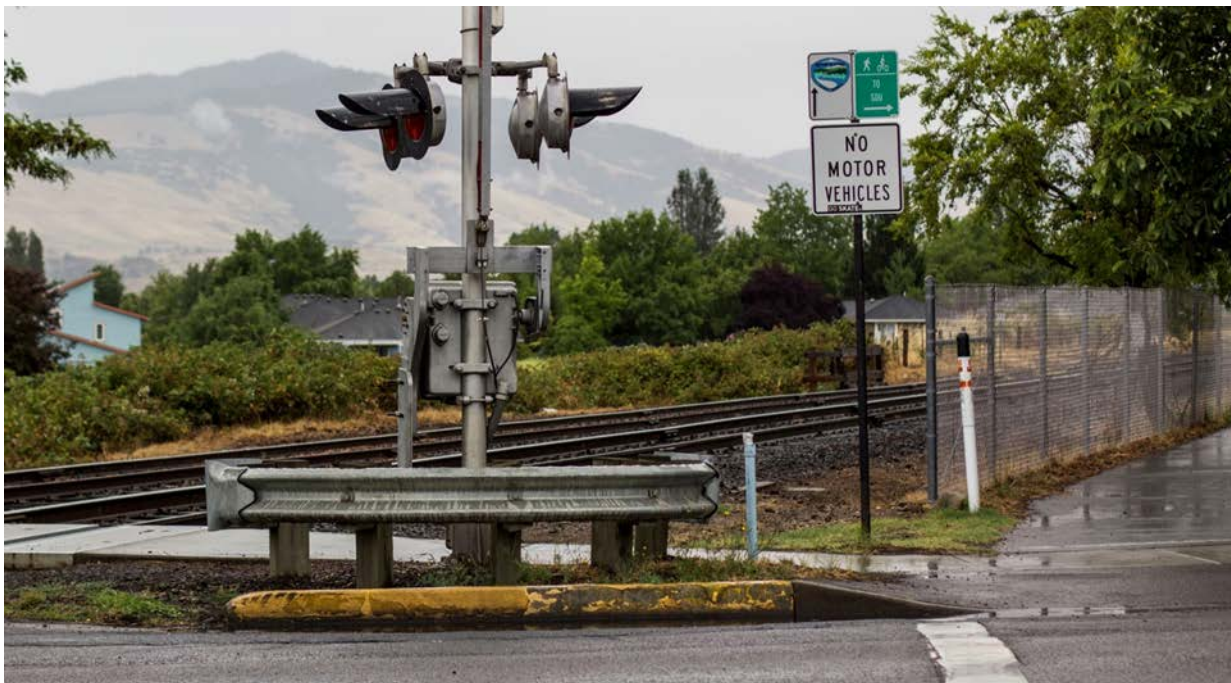
**Figure 3.46: The active treatments and the trailhead at the N Mountain Ave crossing**

The treatment at this site are primarily active and included active lights and active gates, along with bells. The site was also equipped with cross bucks. Stop lines were used to indicate where bikes and cars should stop for trail users and trains.

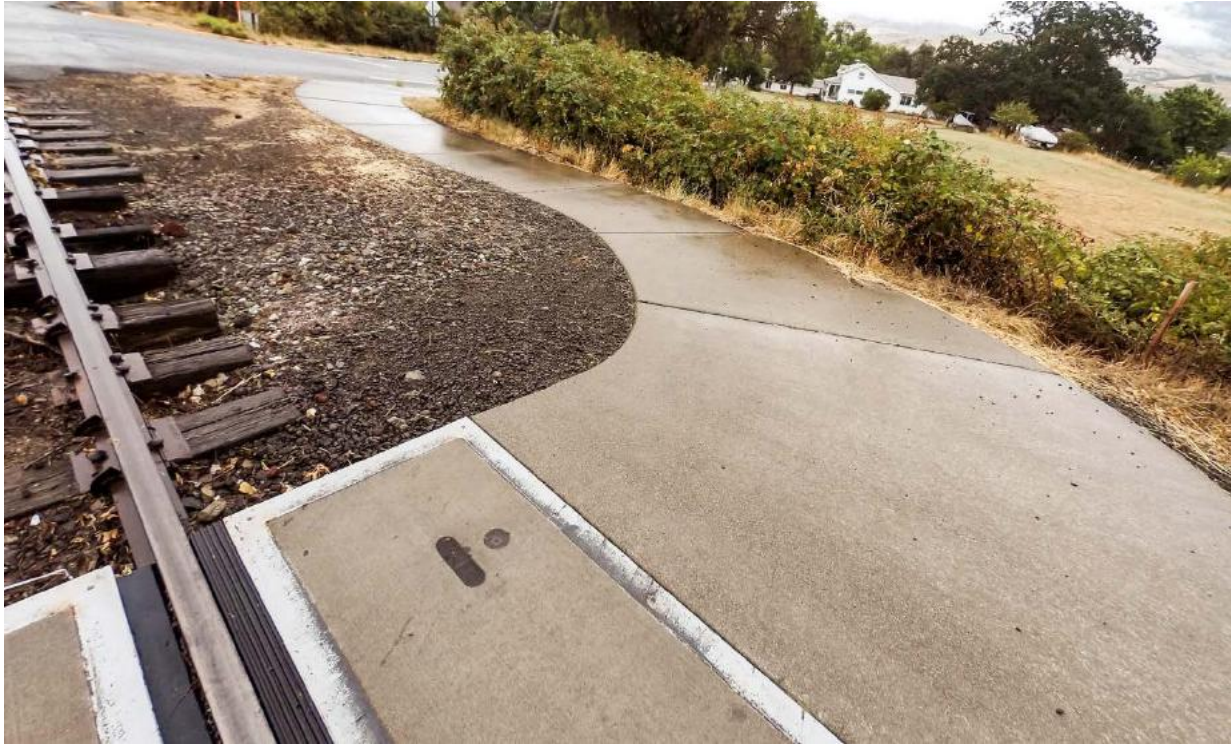
**Figure 3.47: Curving the foot path enables pedestrians and bikes to cross at a 90° angle, to meet ADA access and encourages pedestrians to look to the sides before crossing**

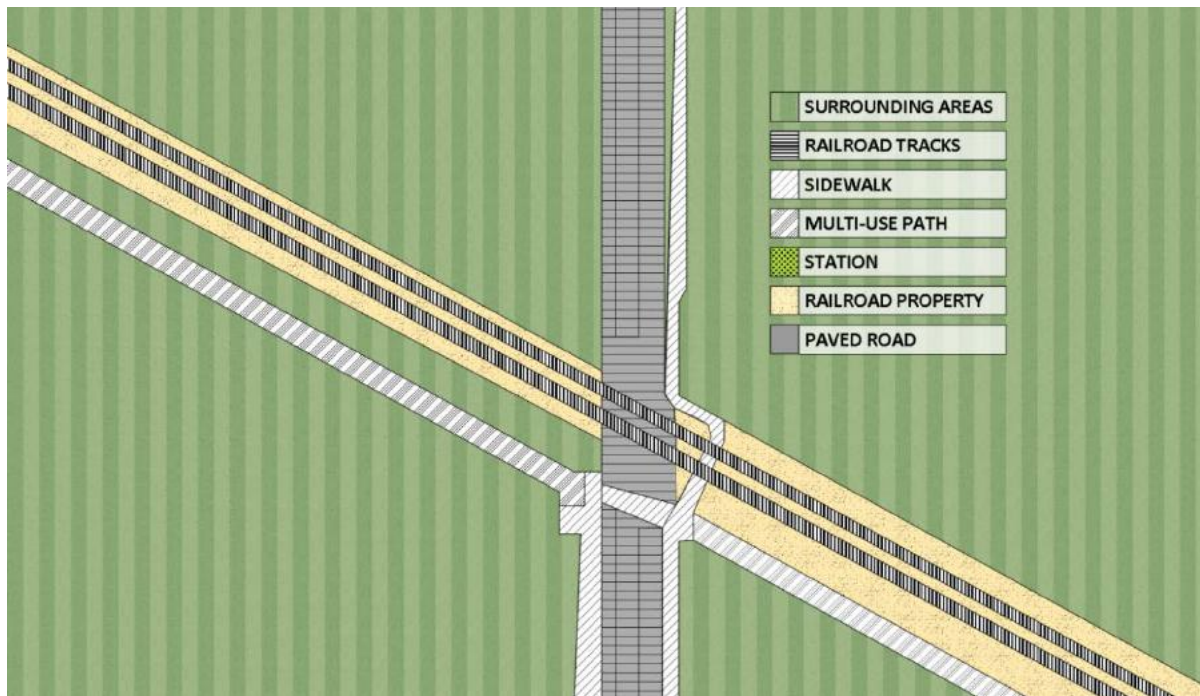
Figure 3.50: N Mountain Ave.

A simplified diagram of N Mountain Ave. is included below to exemplify the dynamic movements of road and path users at this crossing.

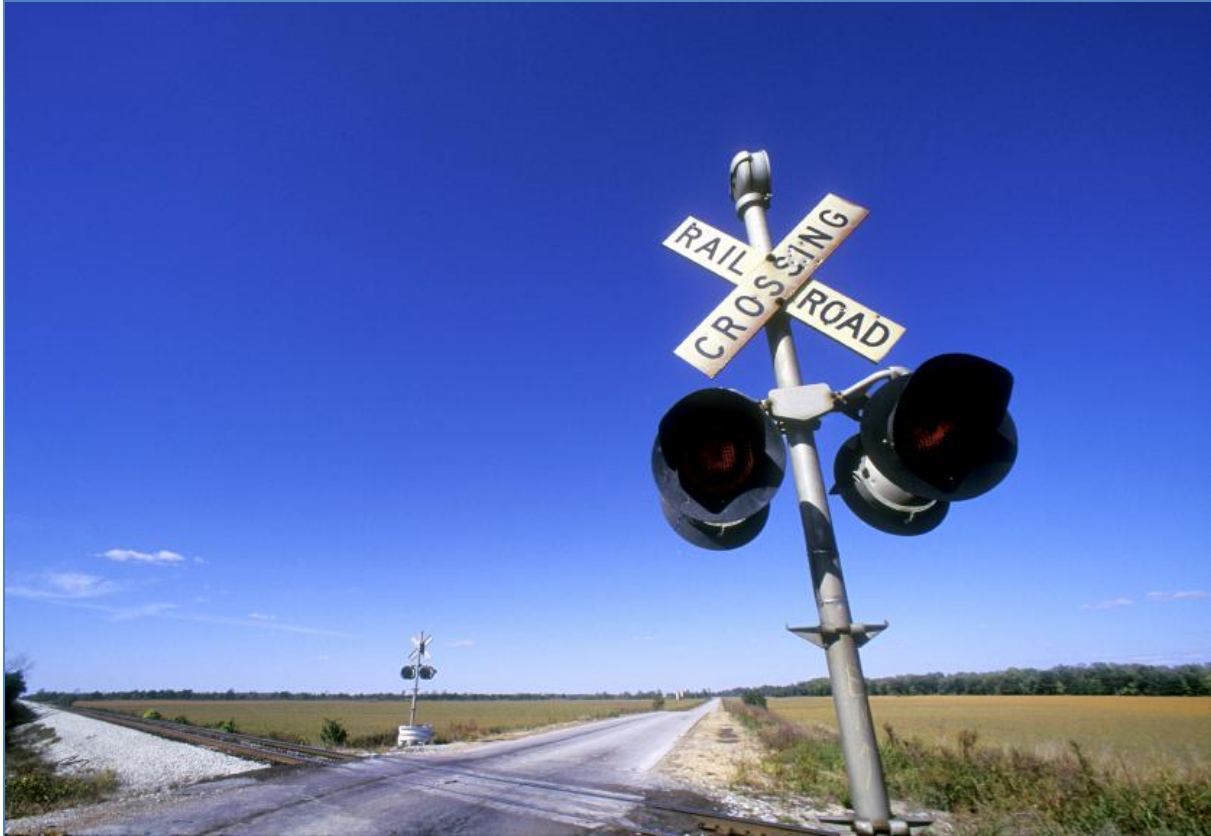
**Figure 5.1: Flashing Light Signal (Mixon, 2015)**

Flashing light signals indicate that a train is approaching and that all road users must come to a full stop at the flashing red lights. Depending on the state of implementation, road users may either proceed after the train passes while the lights are still flashing or they must wait until the flashing stops. In Oregon, “you must treat these devices as a stop sign or red traffic light. Always stop when the lights begin to flash; this means a train is coming” (Oregon Operations Lifesaver, N/A). This is confirmed and supported by Oregon state statutes. It is considered a traffic violation if a driver does not come to a full stop. If there is more than one track, make sure all tracks are clear before crossing. Do not continue through the crossing until it is clear and the lights cease flashing”

According to a case study in Portland, Oregon, a low-rise flash beacon with flashing lights installed a few feet off the ground for pedestrians in tandem with channelization (fencing) treatment improved pedestrian behavior (Boucher, et al., 2008). Another report focusing on driver behavior reports a low compliance rate of flashing light signals by drivers and suggests that to improve efficacy, flashing lights should be paired with automatic gates. In this study, it was found that accident rates decreased by 44% with the addition of gates (Mortimer, 1988). A more recent study focusing on driver behavior supports the idea that flashing lights alone are not optimally effective. This study showed that 67% of drivers violated the crossing when flashing lights and bells were present, and non-compliance rates decreased to 38% when a gate was added (Meeker, Fox, & Weber, A comparison of driver behavior at railroad grade crossings with two different protection systems, 1997).
