**MULTI-MODAL INTERSECTIONS:  
RESOLVING CONFLICTS  
BETWEEN TRAINS, MOTOR  
VEHICLES, BICYCLISTS AND  
PEDESTRIANS**

**Final Report**

**SPR 794**

Oregon Department of Transportation

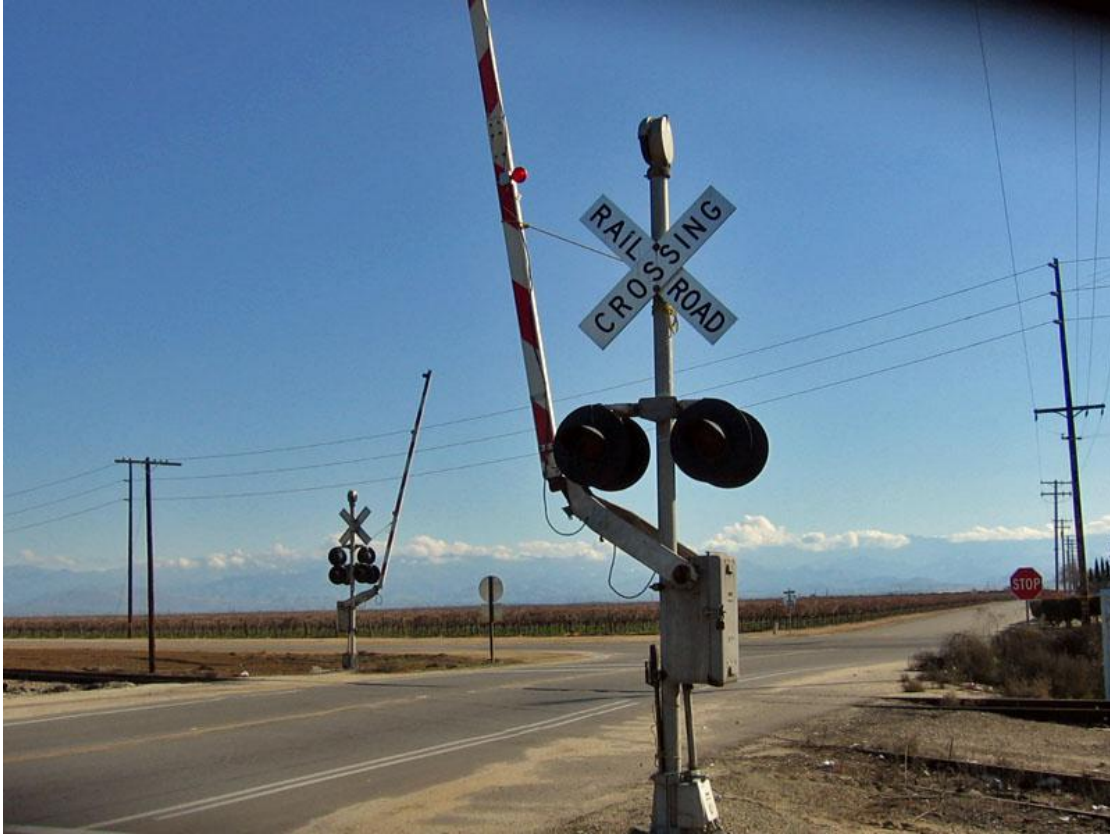
**Figure 5.2: Bells (Steck, N/A)**

The Oregon Department of Transportation (ODOT) requires bells at all signalized railroad crossings.

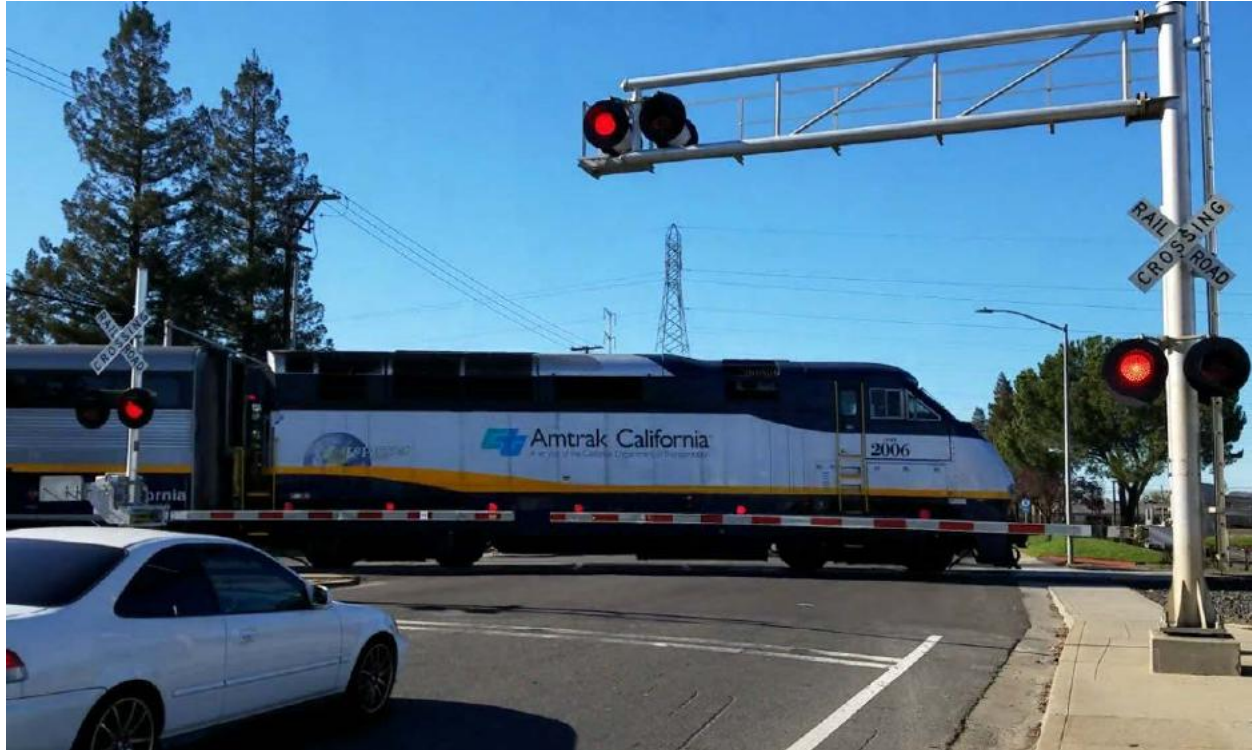
**Figure 5.3: Vehicle Automatic Gates (N/A, N/A)**

Operation Lifesaver in Oregon clarifies the law at railroad gates. "Gated crossings are a further refinement of flashing light signals. They mean the same as ordinary flashing light signals. Stop when the lights begin to flash and before the gate begins to lower across your road lane. Do not attempt to cross until the gates are raised and the lights have stopped flashing. Do not attempt to drive around the gates. Do not stop directly on a gated crossing where there is the risk of getting trapped on it by lowered gates" (Oregon Operations Lifesaver, N/A).

Automatic gates and lights are expensive to implement and cost \$150,000-\$250,000 (Ogden, 2007).

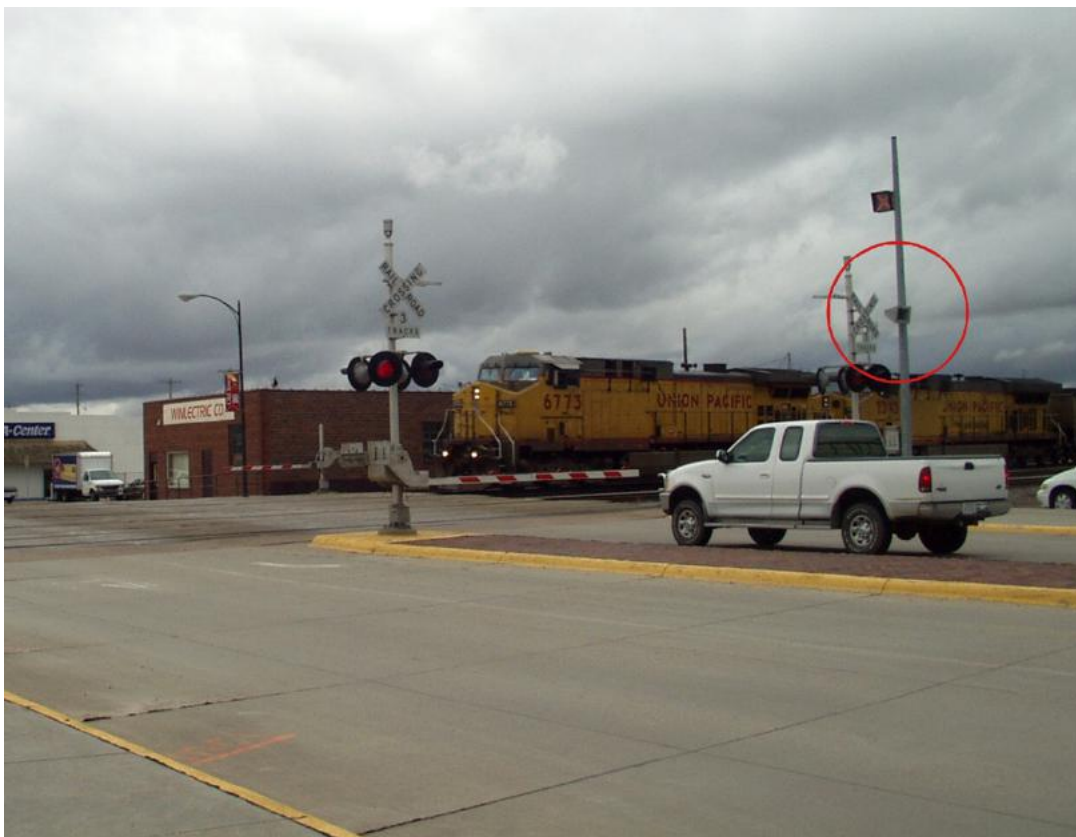
**Figure 5.4: Wayside Horn System (APWA Reporter, 2007)**

Railroad crossings in quiet zones must find alternative warning methods to the train blowing its horn down the railroad and disturbing communities. The wayside horn system is made up of a combination of speakers and a flashing red 'X' installed at a crossing. The speakers emit a digitized train horn down onto the tracks, which is quieter when compared to a train horn which travels down the railroad tracks. The flashing 'X' functions to inform the train crew that the wayside horn system is indeed working, and they then refrain from blowing the train horn when approaching a crossing (WSDOT, 2009). The sound waves moving downward onto the tracks by the wayside horn system allows for the sound warning system to function while also adhering to noise level restraints.

Wayside horn systems are expensive to implement. It costs approximately \$100,000 to add this system to a crossing (National Highway Traffic Safety Administration (NHTSA), N/A). No additional information or data on its efficacy.

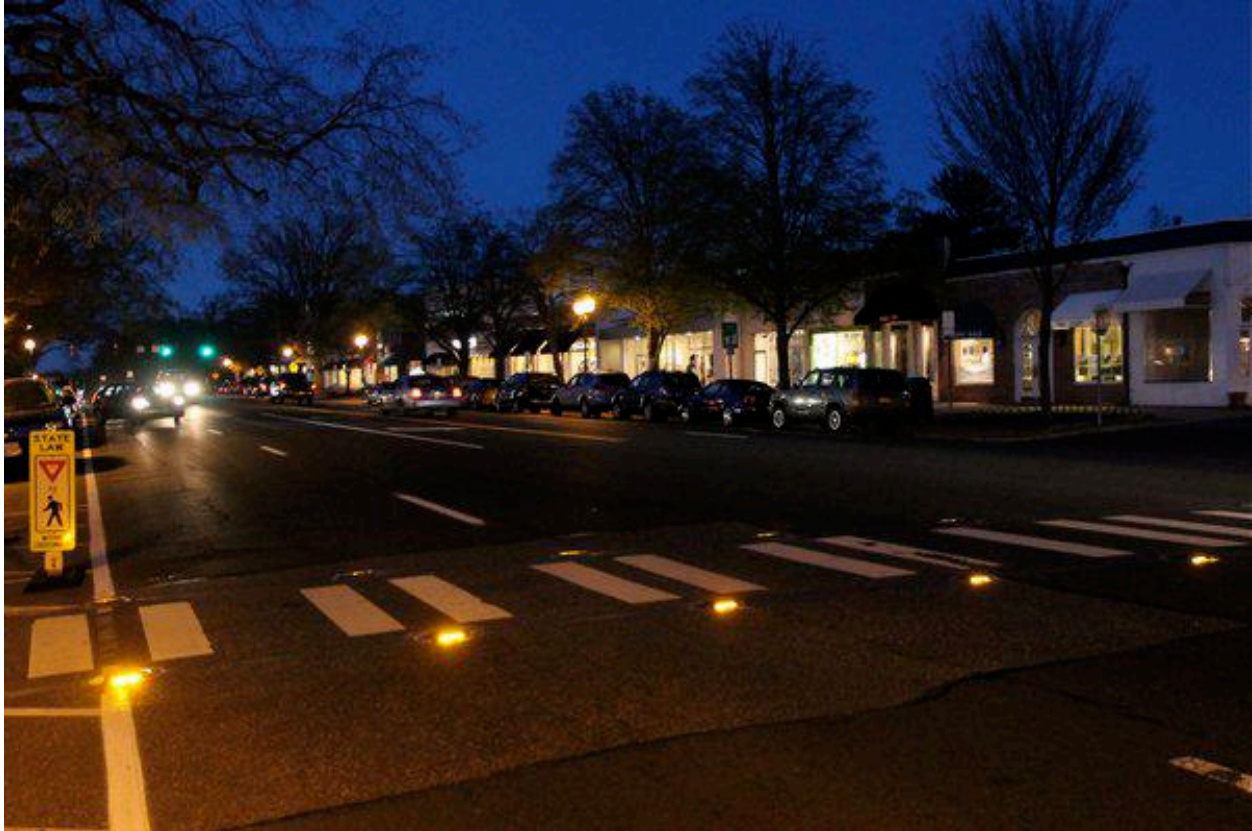
**Figure 5.5: In-Pavement Marker System (Bromley, 2013)**

This can be an expensive installation process that ranges from \$5,000-\$100,000. When this treatment was applied to a highway-rail crossing in Paramount, California to improve sight-distance, it cost about \$60,000. It is a system that requires cumbersome installation and maintenance such as removing and replacing LED lights. Visibility of the LED lights is lower during the daytime and this system relies on a power supply.

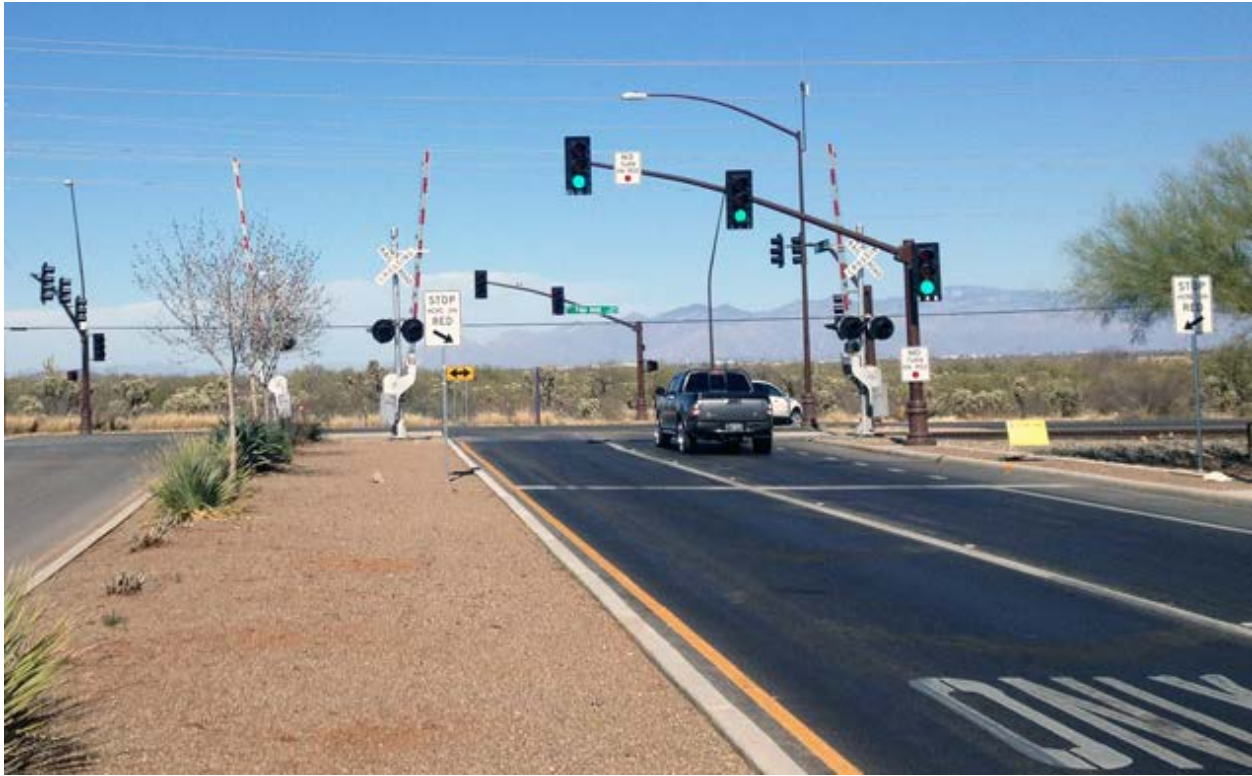
**Figure 5.6: Pre-Signals/Traffic Lights (PSOMAS, N/A)**

This treatment method is typically applied to highway-railroad grade crossings and is used to warn vehicles using pre-signals to mitigate conflict at railroad crossings where vehicles may be in a queue. The pre-signal is used in conjunction with the intersection signal and it requires a traffic signal warrant. More information about the warrant can be found in Section 4C.01 in the MUTCD. When a train is approaching, the red light is activated to stop vehicles before the railroad crossing. “The purpose of installing highway traffic signals in this manner at a crossing is to prevent vehicles from queuing across the grade crossing and finding themselves stopped on the tracks in the area now known as the minimum track clearance distance” (Gilleran, 2006). Although there is no national standard enforcing pre-signals at highway railroad crossings, section 4D.14 and 4D.15 of the MUTCD and FHWA’s November 5, 2014 Official Interpretation 8(09)-19(I)

The pre-signal for the traffic signal ahead of it and emits green, yellow, or red depending on crossing conditions. To create a cohesive and desirable pre-signal, “No Turn on Red” and “Stop Here on Red” sign should also be installed. Regarding heavy rail in Oregon:

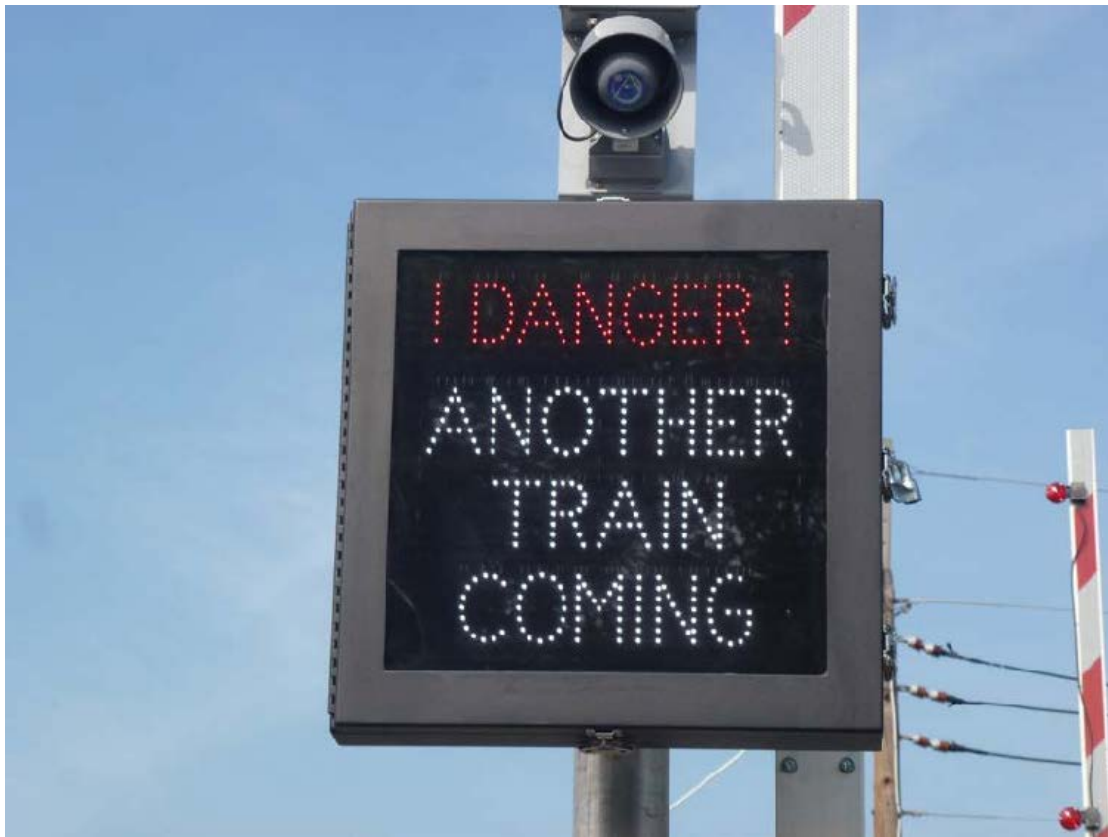
**Figure 5.7: Variable Message Signs (Gabree & daSilva, 2014)**

A variety of Flashing LED Messages are available such as: “Train Approaching,” “Second Train Approaching,” “Warning! Another Train Coming,” and an arrow indicating no right turn. Depending on roadway operations/configuration this may not just be limited to a right turn.

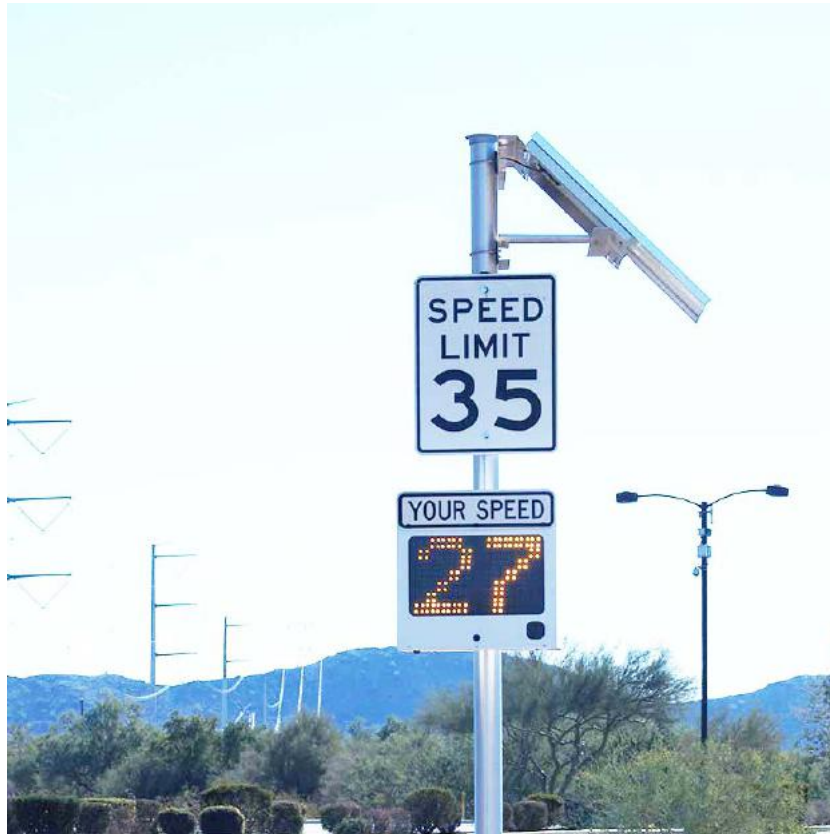
**Figure 5.8: Dynamic Speed Monitoring Display (N/A, N/A, n.d.)**

Another study entitled, “Efficacy of Radar Speed Monitoring Displays in Reducing Vehicle Speeds” implemented three DSMDs in Nebraska. In aggregating and comparing traffic speeds before and after implementation, it was found that the mean speed reduced by 3-4mph and the 85<sup>th</sup> percentile speed reduced by 2-7 mph. Within this study, the DSMD was tested at various other locations, all of which had positive results and showed unanimous efficacy in alerting and slowing down drivers.

If battery operated, there are high maintenance costs, however it can also be implemented with a solar panel to avoid frequent maintenance.

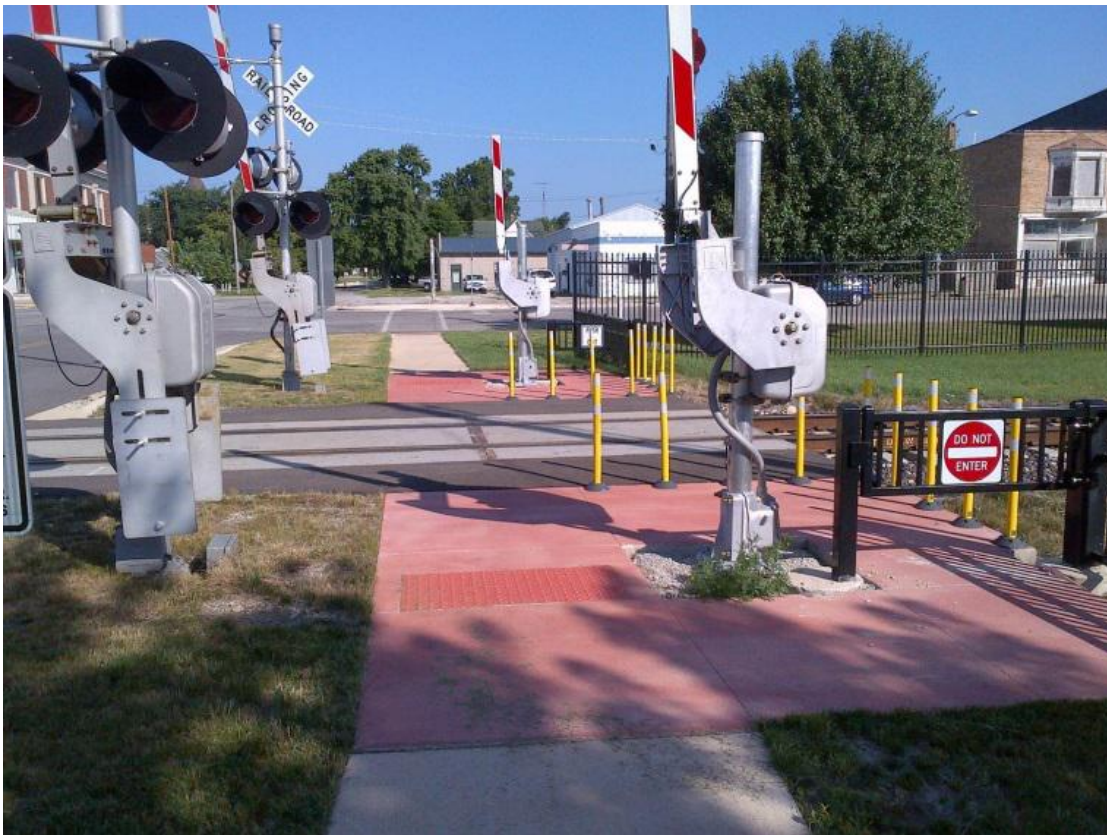
**Figure 5.9: Pedestrian Automatic Gates (N/A, N/A, n.d.)**

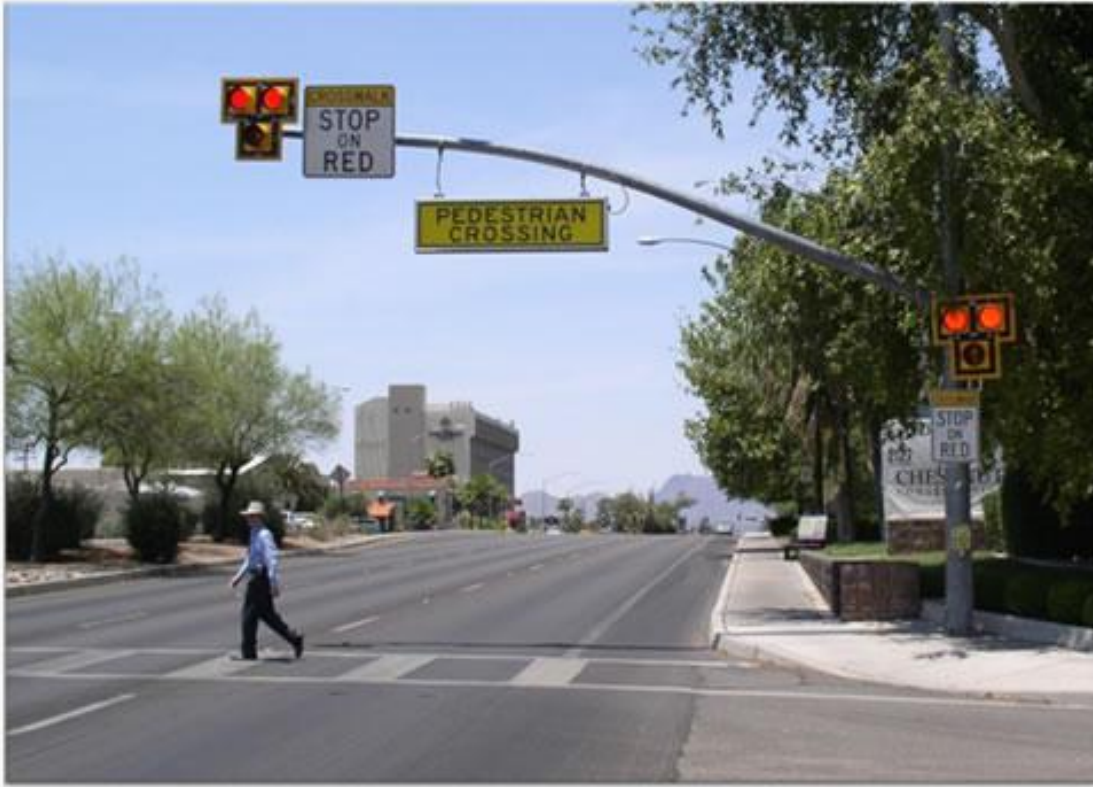
**Figure 5.10: High-Intensity Activated Crosswalk (HAWK) (USDOT FHWA, 2016)**

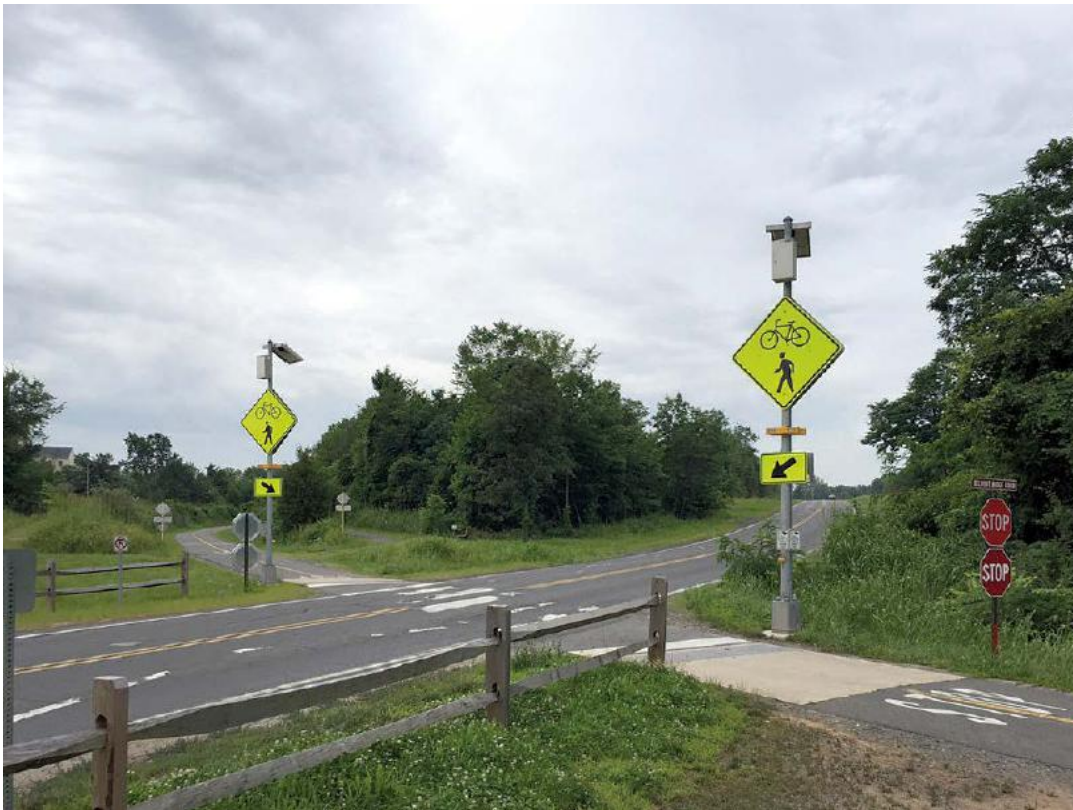
**Figure 5.11: Rectangular Rapid Flash Beacon (RRFB) (N/A, N/A, N/A)**

The cost of an RRFB “is approximately \$10,000 to \$15,000 for purchase and installation of two units (one on either side of a street). This includes solar panels for powering the units, pad lighting, indication units (for both sides of street) with RRFBs in the back and front of each unit, signage on both approaches, all posts, and either passive infrared detection or push buttons with audio instructions. Costs would be proportionately higher for additional units placed on a median island, etc.” (USDOT - FHWA, 2009).

The FHWA estimates that an RRFB costs on average \$22,250 (USDOT - FHWA, N/A). Note that the final cost is likely to deviate from this average depending on site-specific conditions and needs such as interconnecting the RRFB signal with the railroad crossing signal. There have been no outstanding differences in costs between an automatic or pushbutton RRFB.

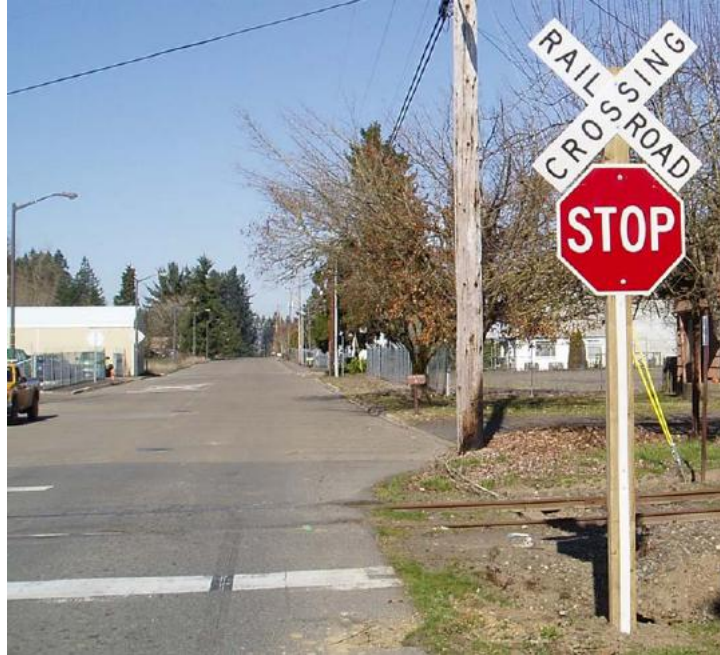
**Figure 5.12: Crossbucks + Stop (ODOT, N/A)**

A study on stop signs at highway-rail crossings in seven Midwestern states concludes that collision rates increased when ‘Stop’ signs are added to ‘Crossbucks’ signs. The author speculates that there is a lower compliance rate of ‘Stop’ signs at low-volume intersections (Raub, 2006). A recent study on driving performance at ‘Crossbucks’ or ‘Crossbucks + Stop’ conflicts this previous study. This research found that almost 100% of their sample population reduced their speed and engaged their brake at a ‘Crossbucks + Stop’ sign versus just 56% that slowed down at a ‘Crossbucks’ sign (USDOT - FRA, 2014). This was surprising to find since national statistics on incidents at ‘Crossbucks’ vs. ‘Crossbucks + Stop Sign’ between 2008-2012. Suggest that more railroad incidents occurred at ‘Crossbucks’ only signs than at ‘Crossbucks + Stop Signs.’

It costs \$1,200-\$2,000 to install (FHWA, 2007). There is concern of rollover stoppings onto the tracks, which increases exposure time to the train.

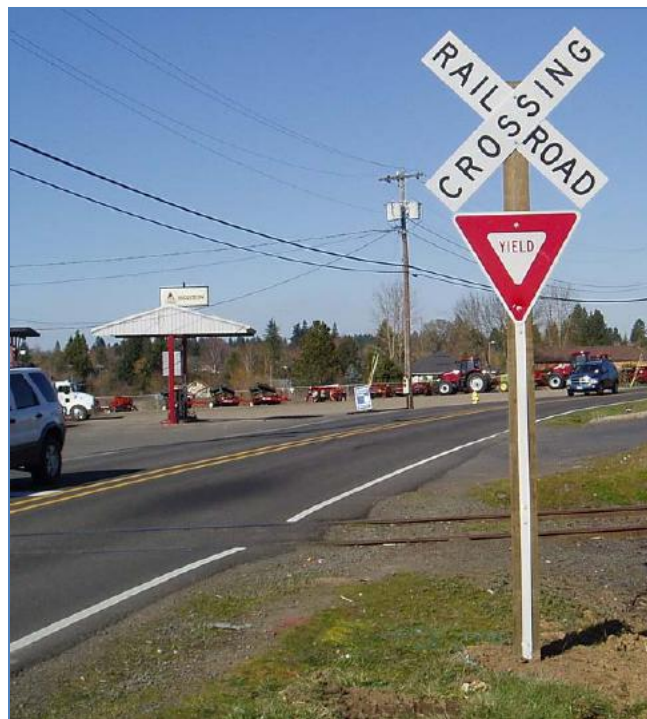
**Figure 5.13: Crossbucks + Yield (ODOT, N/A)**

The Yield sign emphasizes that road users must slow down and yield to oncoming railroad traffic. Research done by Lumm and Stockton suggest that ‘Yield’ signs are more effective at having drivers slow to 5 miles per hours or under than ‘Stop’ signs. It costs \$1,200-\$2,000 to install (FHWA, 2007).

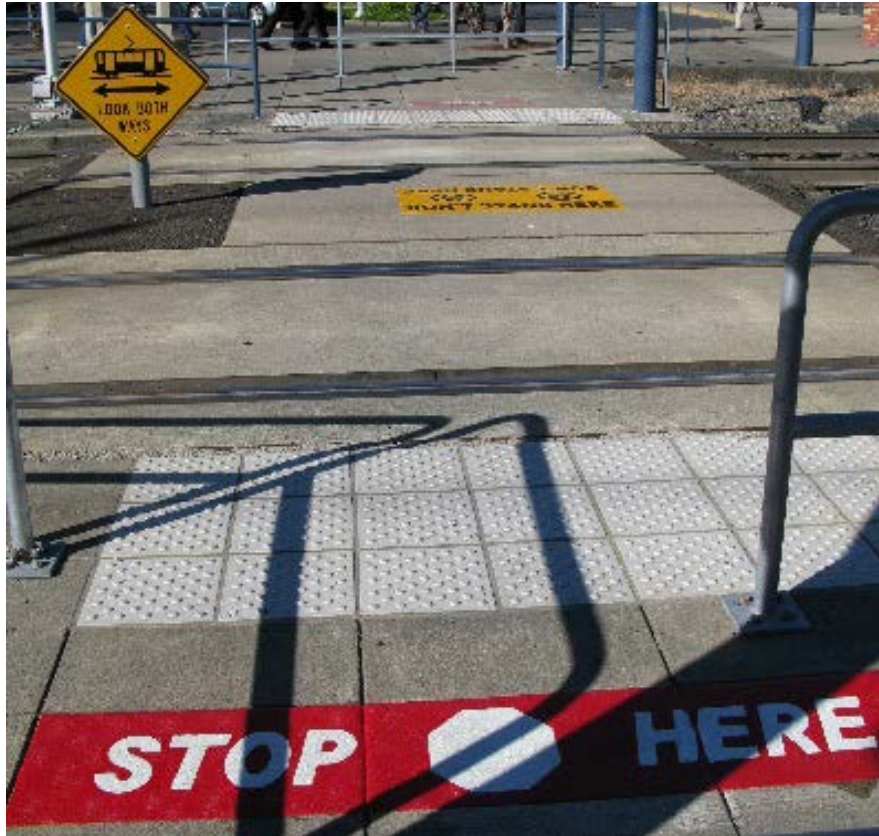
**Figure 5.16: Pavement Marking (N/A, N/A)**

The highway-rail grade crossing is a white RxR symbol that is marked on the road near the advance warning sign and may also include a stop bar to signal that drivers must come to a full stop before the white line if a train is present. Stop lines, crosswalks, and all other pavement markings are included under "Pavement Marking."

Pavement signs painted on the panels near railways with warnings such as "Stop for Trains, Look for Trains in Both Directions, Stop Here, Do Not Stand Here, Watch for Trains. Salt Lake City, Utah is currently evaluating the effectiveness of this treatment option (Boucher, et al., 2008). Though the efficacy of this treatment has not been recorded since then, the UTA Light Rail Design Criteria approves of pavement markings as long as they adhere to Utah MUTCD requirements (Utah Transit Authority, 2015). All pavement markings are prone to low visibility during extreme weather conditions and may require frequent maintenance to maintain visibility and clarity.

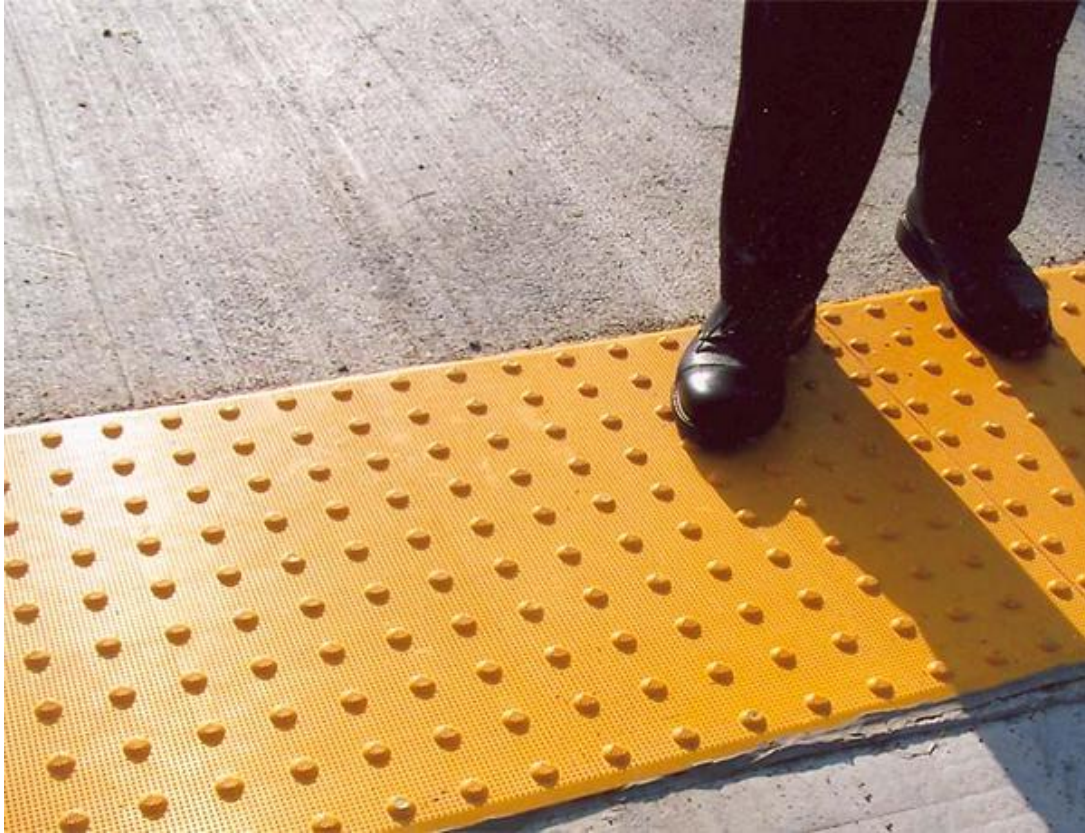
**Figure 5.17: Tactile Warning (N/A, N/A, N/A)**

Road texture such as bumpers and rumble strips for cyclists assist in heightening awareness train presence and forces cyclists to reduce their speed as they approach an at grade crossing and can also serve as an audible warning method (Yeh & Multer, 2008). It is interesting to note that tactile warning treatments may also cause reckless behavior if users try to avoid the textured surfaces (Yeh & Multer, 2008). This is a rather low-cost treatment that requires frequent maintenance to keep markings clear and visible. Snow can obstruct the visibility and effectiveness of tactile treatment methods. Tactile treatment methods are widely used in the United States and there are many professionals

in the field who firmly believe that this treatment method undoubtedly improves low-risk behavior for pedestrians, visually impaired, and cyclists. However, there is no additional information or data on its efficacy (Cleghorn, Clavelle, Boone, Masliah, & Levinson, 2009).

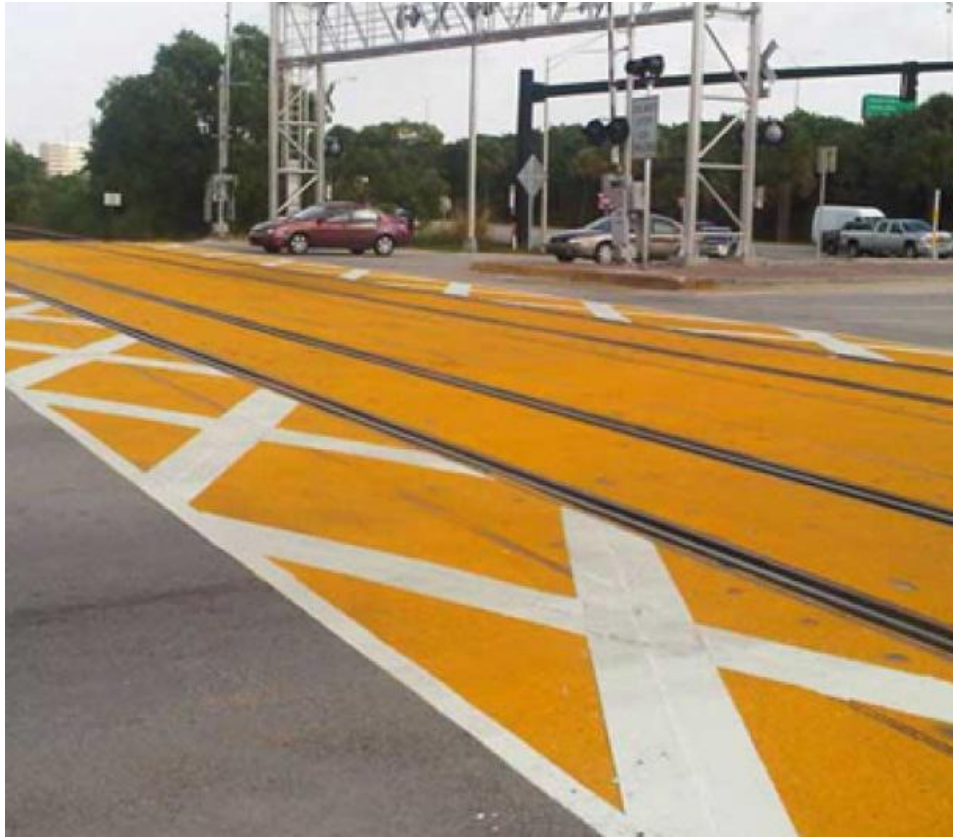
**Figure 5.18: Figure Dynamic Envelope (N/A)**

The MUTCD defines a dynamic envelope “as the clearance required for the train or light rail transit equipment overhang resulting from any combination of loading, lateral motion, or suspension failure” (MUTCD, 2009).

Different design measures can be used to deter road users from dwelling in the dynamic envelope such as barrier curbs and tactile treatments within the envelope to make it uncomfortable to ride a bike or walk on uneven pavement, ultimately discouraging people from dwelling on the tracks. Paint covering the dynamic envelope marking is another treatment option to emphasize train-activated space on the road. Depending on the type of treatment and site specifics, the cost and maintenance levels will vary. According to Transpo Industry Inc., a company that specializes on painting dynamic envelope marking this treatment resulted in a 39% reduction in the number of motorists stopping on or near tracks.

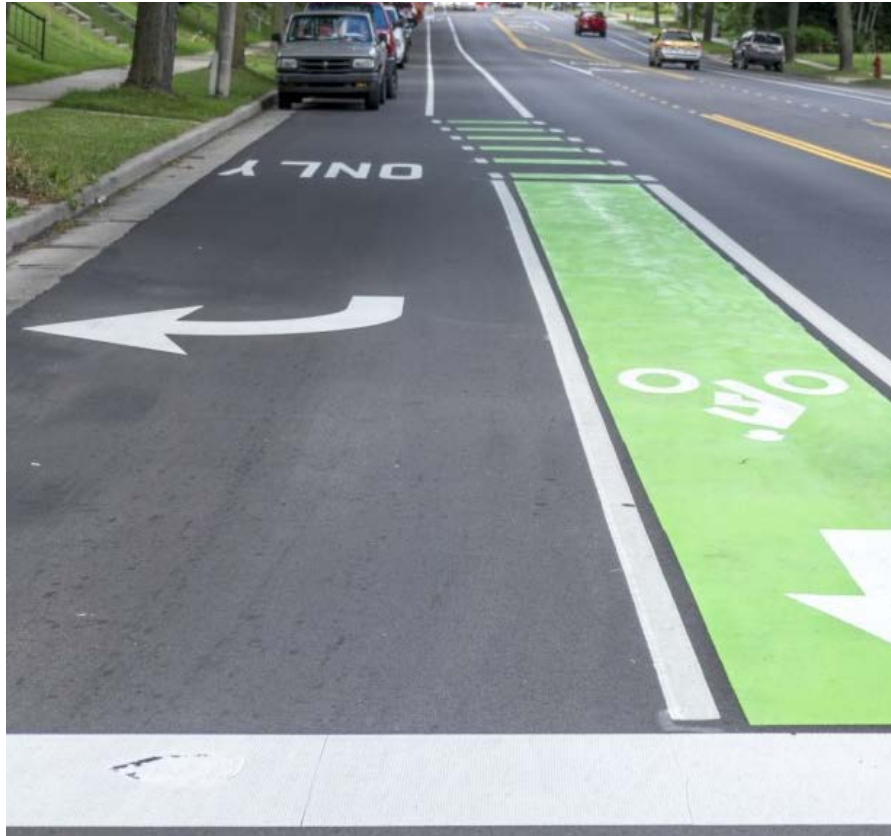
**Figure 5.19: Conflict Paint (Cieslewicz, seen 2017)**

According to the National Association of City Transportation Officials' (NACTO) Urban Bikeway Design Guide, green paint is the color of choice because other colors have other meanings in the pavement marking context. In addition to the paint being green, NACTO recommends that the colored surface be prepared to be skid resistant and retro-reflective to optimize visibility in the dark. They also encourage cities to implement 'Yield to Bikes' signs to clarify and emphasize that bicycles have right-of-way. "Bicyclists familiar with more traditional sharrows have noted that the additional emphasis resulting from the green pavement paint appears to be creating a heightened awareness by the motorists in the lane" (KOA Corporation, 2010).

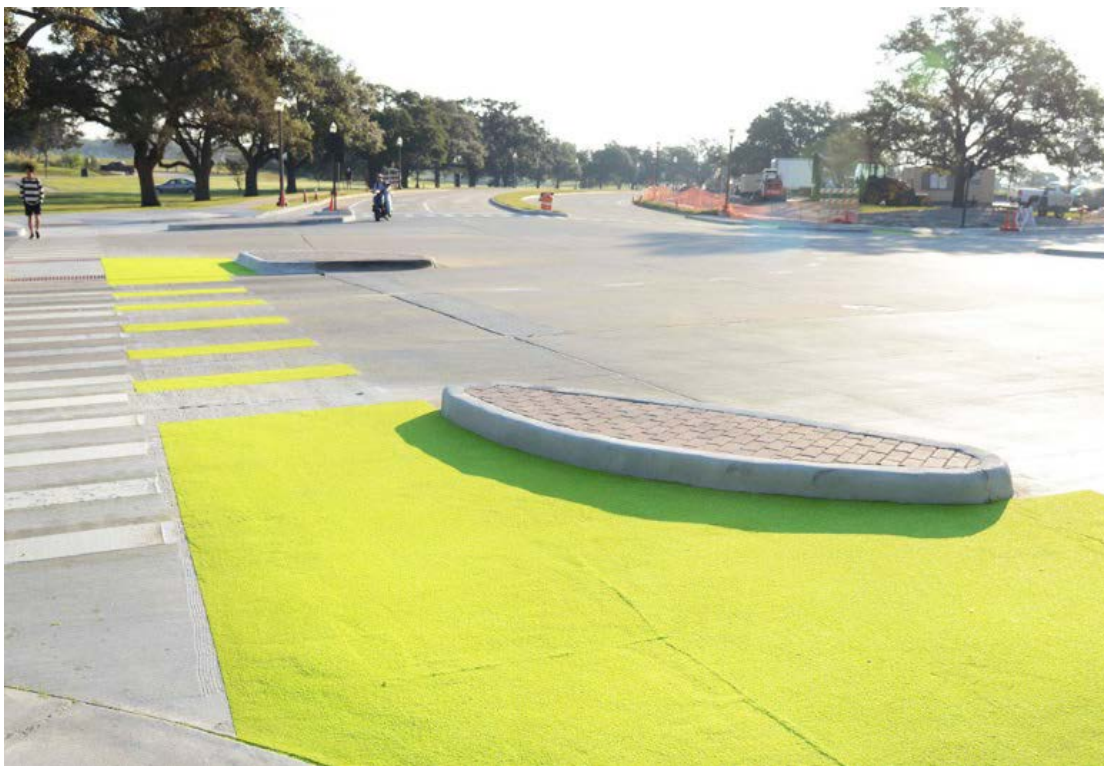
**Figure 5.20: Glow in the Dark Paint - Day Visibility (Texas A&M, 2017)**

Texas A&M University received approval from the Federal Highway Administration to test this specially formulated paint on their campus and record the efficacy of this treatment option. During the day, photo luminescent particles soak up energy from the sun and this energy then emits a luminous soft glow at night. This treatment is currently being tested at Texas A&M. No additional information on its efficacy (Chow, 2017).

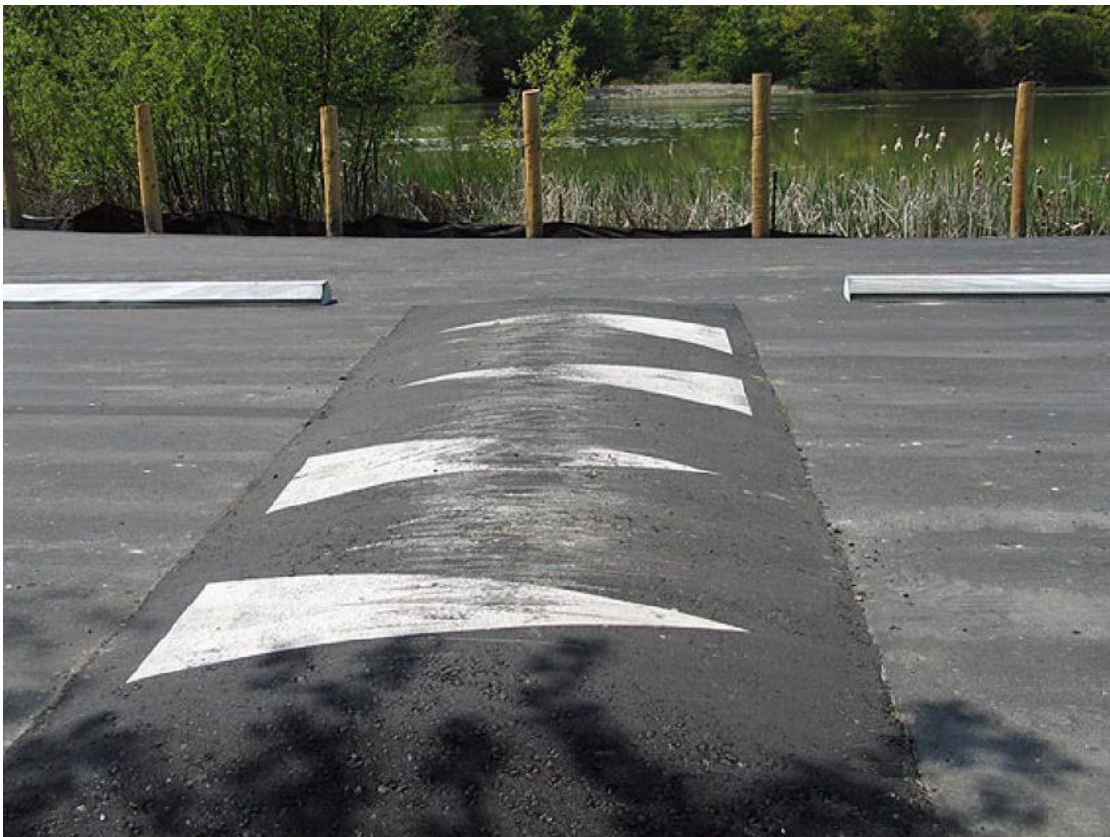
**Figure 5.23: Speed Bump (Lakey, NA)**

Speed bumps are another variation of a traffic calming method typically used for vehicles. A speed bump's design differs from that of a speed hump in that it is more severe and aggressive in slowing down vehicles. "A speed bump is also a raised pavement area across a roadway. Speed bumps are typically found on private roadways and parking lots and do not tend to exhibit consistent design parameters from one installation to another. Speed bumps generally have a height of 3 to 6 inches (76 to 152 mm) with a travel length of 1 to 3 feet (0.3 to 1 m)" (Parkhill, Sooklall, & Bahar, N/A). The presence of speed bumps negatively affects emergency vehicles and their time

sensitive demands. Speed bumps are not conducive to snowplows or other maintenance vehicles as well and can have weather constraints. Like speed humps, speed bumps in the vehicular context also increase fuel usage and consequently emit more CO<sub>2</sub> and pollutants due to the acceleration and braking nature of vehicles around them. This however, may be irrelevant if speed bumps are to be repurposed for pedestrian/bike paths. Note that speed bumps could be considered a nuisance and may impair the quality of experience that path users have, possibly leading to treatment avoidance, and it may also pose a challenge for ADA accessibility. Speed bumps that are implemented for vehicles must be paired with a “Speed Bump” sign, which is included in the MUTCD as Fig. W17-1, but would be written as “Speed Bump” and not “Speed Hump (Moeur, n.d.). Speed bumps can be implemented in a series to increase speed control. Speed bumps can cost between \$540 - \$2,300 (Bushell, Poole, Zeeger, & Rodriguez, 2013).

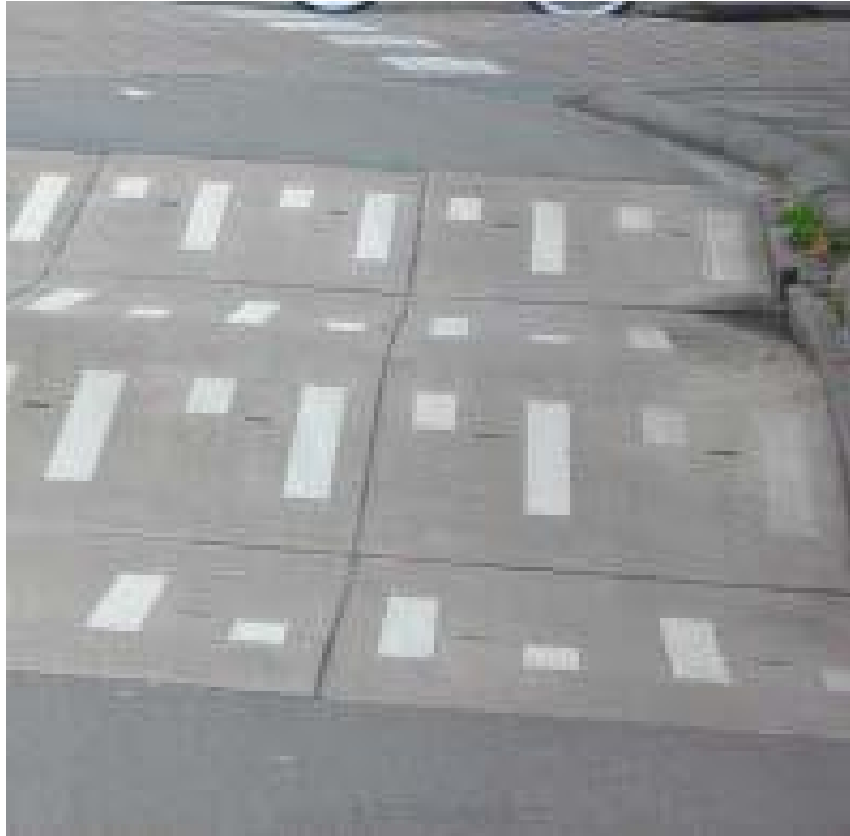
**Figure 5.24: Bicycle Speed Hump (Zach, 2011)**

This is a traffic calming measure associated with cars, however, this concept can be applied to a path in order to decrease the speed of cyclists as they approach an intersection. The speed humps must consider the speed of the cyclist and topography unique to the site before implementation.

The speed hump can reduce the cyclist's speed near the intersection, and therefore may improve behavior for all road users. According to the Minnesota Department of Transit's Bikeway Facility Design Manual, the general bicycle design speed of 20 mph is desirable on a shared-use path. Bicycle speed humps are not a common treatment option used in the United States; however, European cities such as Groningen have implemented these methods to slow down cyclists and mopeds. According to ITE's recommended practice for vehicles, "A speed hump is a raised area in the roadway pavement surface extending transversely across the travel way. Speed humps are sometimes referred to as "pavement undulations" or "sleeping policemen". Most agencies implement speed humps with a height of 3 to 3.5 inches (76 to 90 mm) and a travel length of 12 to 14 feet (3.7 to 4.3 m). Speed humps are generally used on residential local streets" (Parkhill, Sooklall, & Bahar, N/A). The presence of speed humps negatively affects emergency vehicles and their time sensitive demands. Speed humps are not conducive to snowplows as well and can have weather constraints. Speed humps in the vehicular context also increase fuel usage and consequently emits more CO<sub>2</sub> and pollutants due to the acceleration and braking nature around them. This however, may be irrelevant if speed humps are to be repurposed for pedestrian/bike paths. Note that speed humps could be considered a nuisance and may impair the quality of experience that path users have and it may also pose a challenge for ADA accessibility. Speeds humps that are implemented for vehicles must be paired with a "Speed Hump" sign, which is included in the MUTCD as Fig. W17-1 (Moeur, n.d.). Speeds humps can be implement in a series to increase speed control. According to research conducted in Seattle of vehicle speeds before and after the implementation of speed humps, researchers found that speeds reduced by between 79%-88% (Fucoloro, 2014). The National Association of City Transportation Officials note that that speed humps reduce vehicle speeds to 15-20 mph. Speed humps for vehicles cost an average of \$7,500, but can range between \$540 - \$7,500 (Bushell, Poole, Zeeger, & Rodriguez, 2013) & (Markon, 2008).

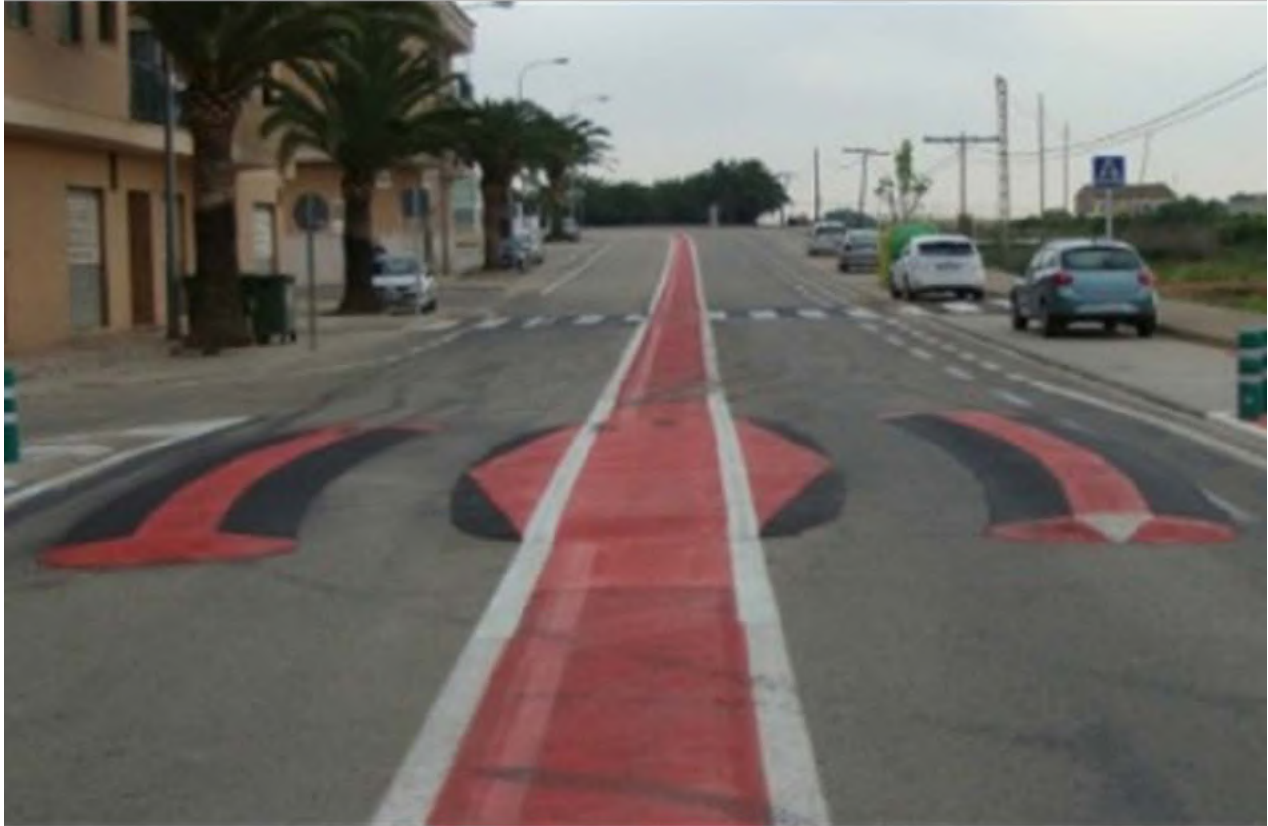
**Figure 5.25: Speed Kidney (Garcia, Alfredo, N/A)**

This is a traffic calming measure to reduce vehicle speed and road volume and to ultimately improve road use and behavior. A speed kidney consists of two main speed humps that straddle a center complementary speed hump. The speed kidney is typically used for vehicles; however, it is possible to adapt this for cyclists on a path. The design has been carefully constructed to encourage vehicle drivers to slow down and curve along the road to avoid discomfort by having any wheels interact with the humps. The design of the speed kidney does a good job serving various path users and does not obstruct the path for any particular path user. This treatment option can be customized to be ADA accessible.

In a long-term study of the efficacy of speed kidneys implemented in Spain, researchers found that 70% of vehicles followed the curve path encouraged by the speed kidney design and therefore reduced their speeds (Garcia, Moreno, & Romero, 2012). Cost of a speed kidney is ranges between \$3,000 - \$7,000 (Bushell, Poole, Zeeger, & Rodriguez, 2013). This estimate is based off of the cost of speed bumps, humps, and tables.

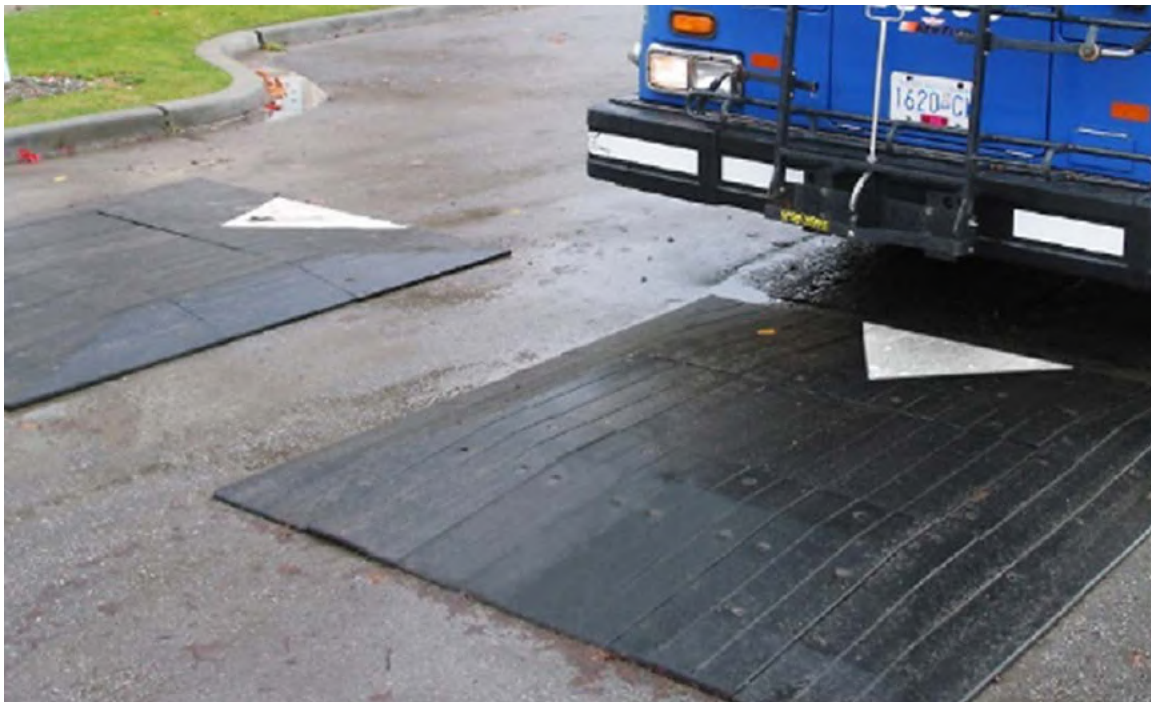
Figure 5.27: Speed Cushion (Drdul, 2006)

Many of the studies observed that speed cushions caused treatment avoidance and therefore, undesired road conditions. In an attempt to avoid the speed cushion and get their wheels in the pockets between speed cushions, drivers would drift between lanes. They may also cause noise pollution and obstruct the road for snowplows or other maintenance vehicles. Note that speed tables must be paired with a “Speed Cushion” sign to alert path users or road users of its presence, which is included in the MUTCD as Fig. W17-1. Speed Cushions cost an average of \$2,800 to install (City of Phoenix, N/A).
