**MULTI-MODAL INTERSECTIONS:  
RESOLVING CONFLICTS  
BETWEEN TRAINS, MOTOR  
VEHICLES, BICYCLISTS AND  
PEDESTRIANS**

**Final Report**

**SPR 794**

Oregon Department of Transportation

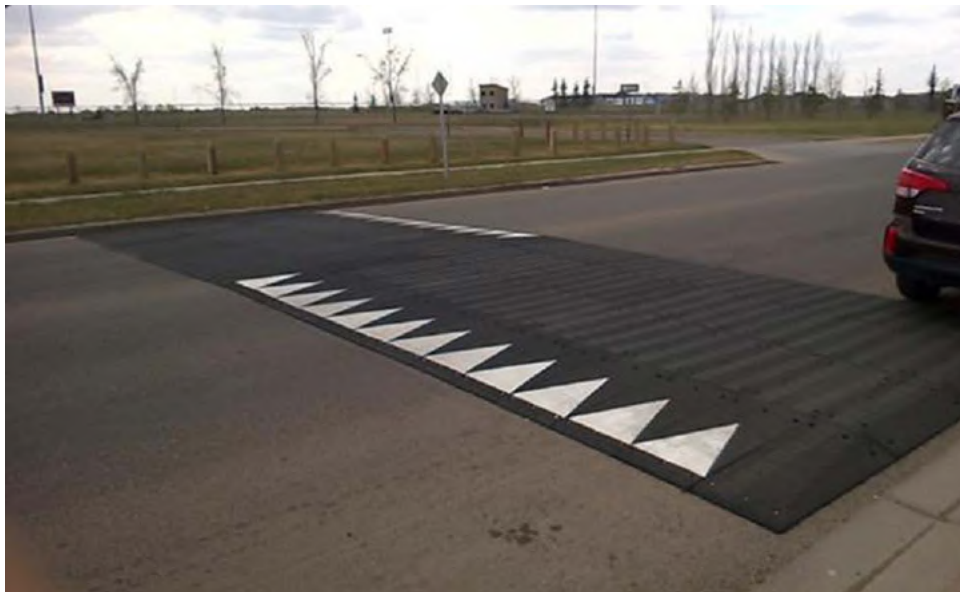
**Figure 5.28: Speed Table (Lloydminster.ca, 2017)**

The City of Portland, OR has designed “split” speed tables for designated emergency routes. Split speed tables are also 22 feet (6.7 m) long and extend from curb to centerline on opposite sides of the street. Split speed tables are separated by a longitudinal gap that allows fire trucks to weave around the split speed humps in slalom-like fashion” (Parkhill, Sooklall, & Bahar, N/A). Speed tables may be implemented in emergency respond routes, but could be inconvenient for larger vehicles and cause delays. They may also cause noise pollution and obstruct the road for snowplows and other maintenance vehicles. Note that speed tables must be paired with a “Speed Table” sign to alert path users or road users of its presence, which is included in the MUTCD as Fig. W17-1.

Depending on the materials used and drainage features, speed tables can cost between \$5,000 – \$15,000 (FHWA, N/A).

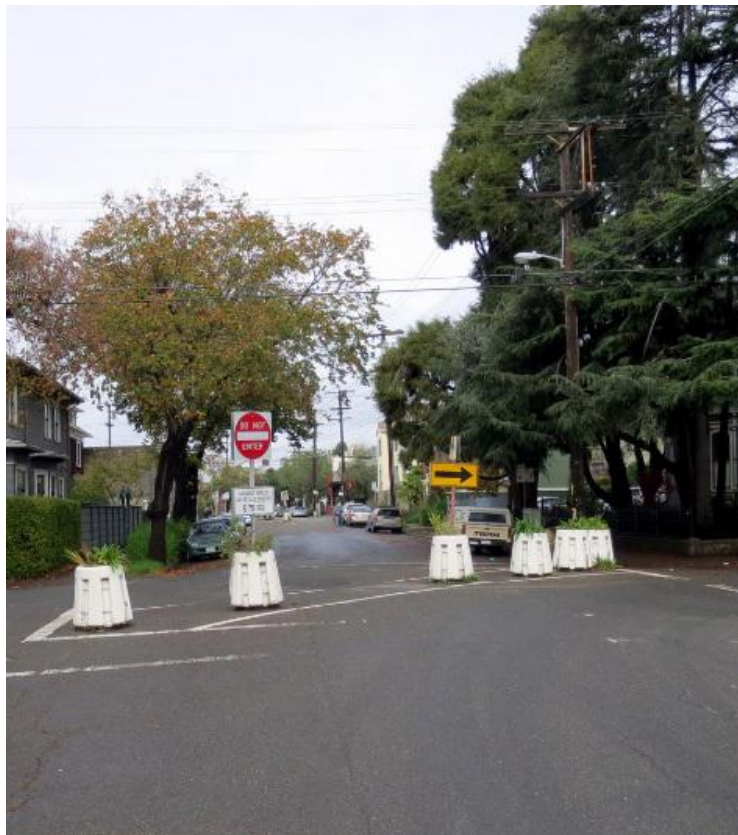
**Figure 5.29: Bollards used to keep vehicles from entering, (N/A, N/A)**

A bollard is a simple, yet effective engineering tool that can be placed on a path near a road intersection to keep vehicles separate from cyclists and pedestrians.

Bollards are used to discourage vehicle drivers from misusing space allocated to cyclists and pedestrians. Bollards can have a range of physical forms (permanent, rising, removable, planters, security, etc.), but they all serve the same function of separating cyclists and pedestrians from vehicles. The cost to implement and maintain the bollards depends on the type of bollard design chosen. However, according to Costs for Pedestrian and Bicyclist Infrastructure Improvements (2013), bollards cost an average of \$730.00. No additional information or data on its efficacy.

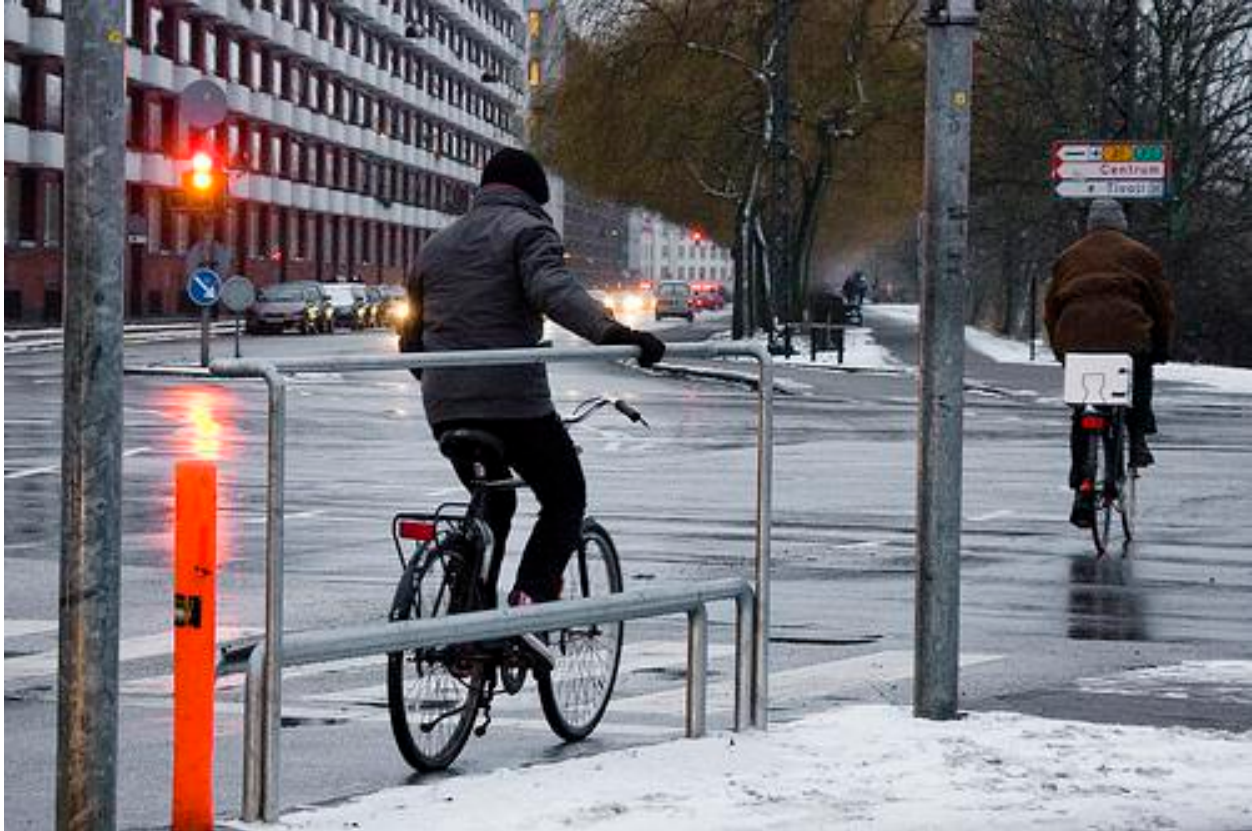
This is a simple design concept that encourages cyclists to adhere to traffic laws by creating comfortable rest space. Rails have been designed and implemented in major biking cities such as Copenhagen and Seattle. It is a low-cost amenity that facilitates low-risk road or path behavior. Construction, labor, and materials for one rail cost about \$2,000 (Cohen, 2015). No additional information on its efficacy.

**Figure 5.30: Bicycle Lean Rail, (Colville-Andersen, Mikael, 2010)**

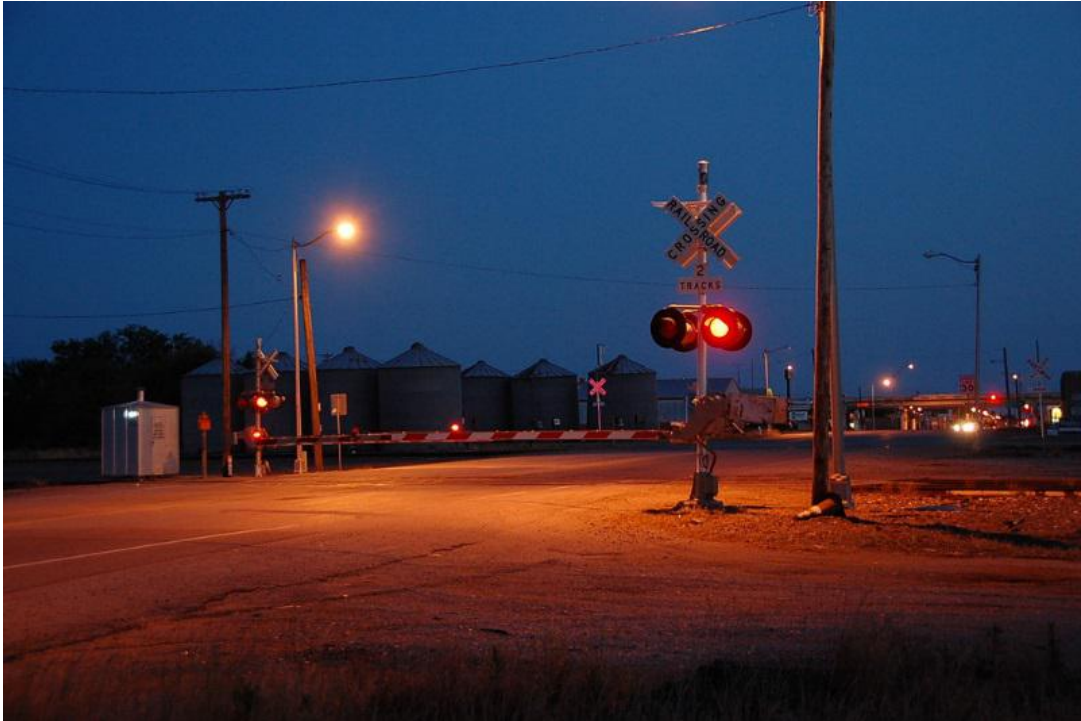
**Figure 5.31: Lighting to illuminate railroad tracks and path, (N/A, N/A)**

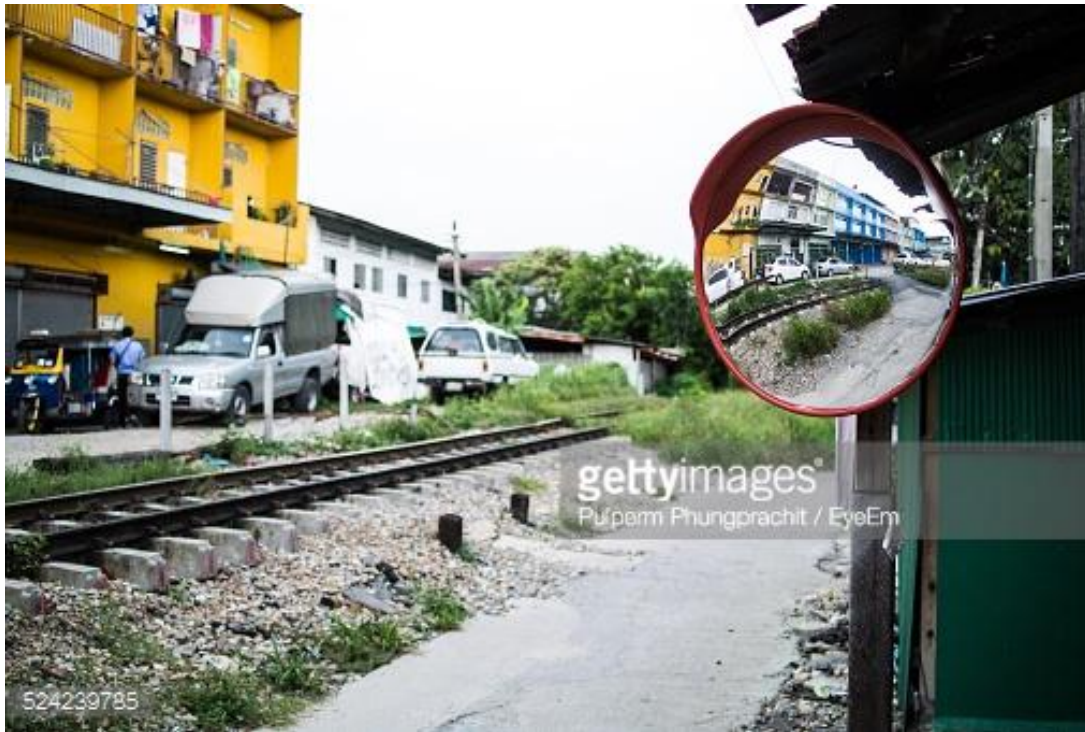
Though this treatment is not common in the United States, it can be repurposed and be applied to paths to increase awareness and visibility of oncoming vehicles or trains for path users.

**Figure 5.32: Mirror (Phungprachit, N/A)**

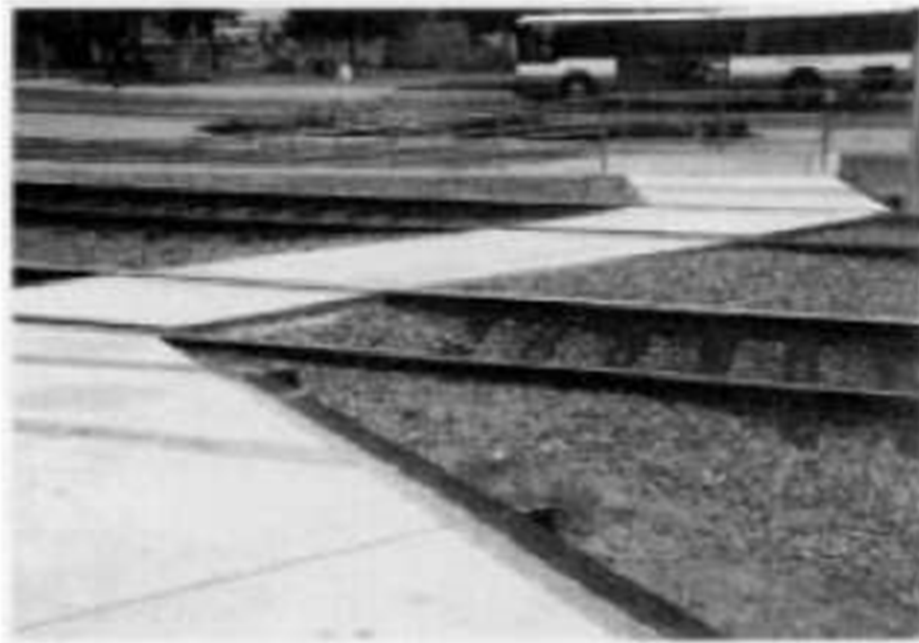
Fencing is placed around the track to guide pedestrians and cyclists through a preferred travel pathway. The design of the channelization also forces pedestrians to look into the direction of oncoming trains and the action of opening the gate slows down movement. It is also recommended that the gate be opened towards the user so as to prevent a scenario where a pedestrian is trapped by the swing gate. It is important to note that Z-crossings cannot be applied at two-way single tracks. Placement of channelization must be strategic since a fence cannot feasibly extend and follow all railroads in the United States. Fencing is expensive to install and maintain.

**Figure 5.33: Channelization, (Korve, Hans W. , Jose I. Farran, Douglas M. Mansel, et al., 1996)**

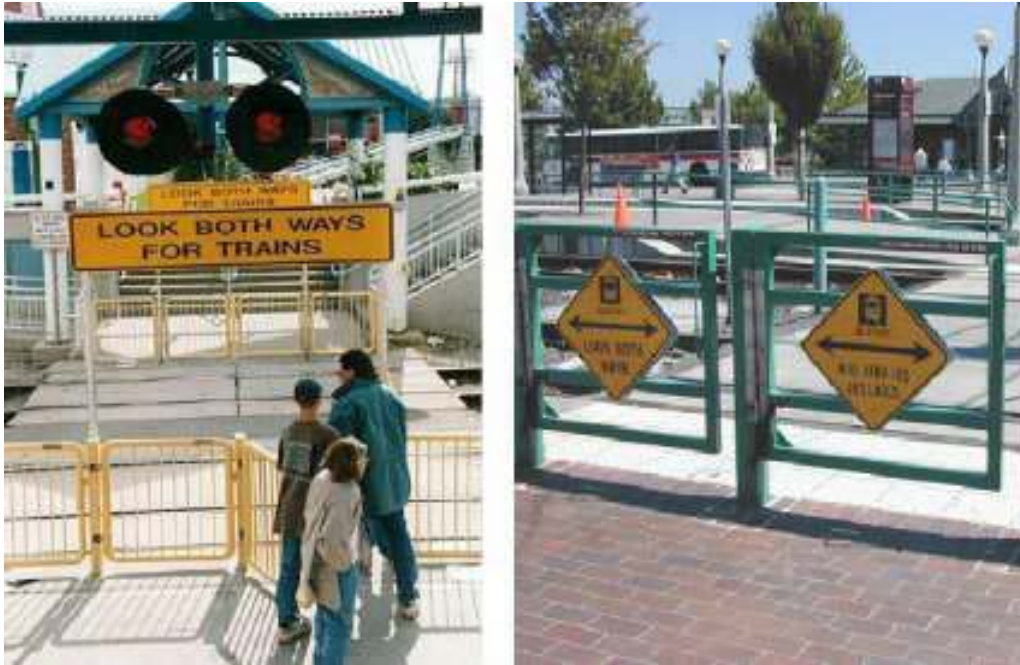
Physical gates which pedestrian or cyclists must manually open and shut to access the railroad crossing. This treatment is intended to slow down nonautomotive traffic and therefore increase awareness of crossing. It is recommended that this be a kick gate so that it is also ADA accessible. No additional information or data on its efficacy.

**Figure 5.34: Pedestrian Manual Gates, (Korve, Hans W. , Jose I. Farran, Douglas M. Mansel, et al., 1996)**

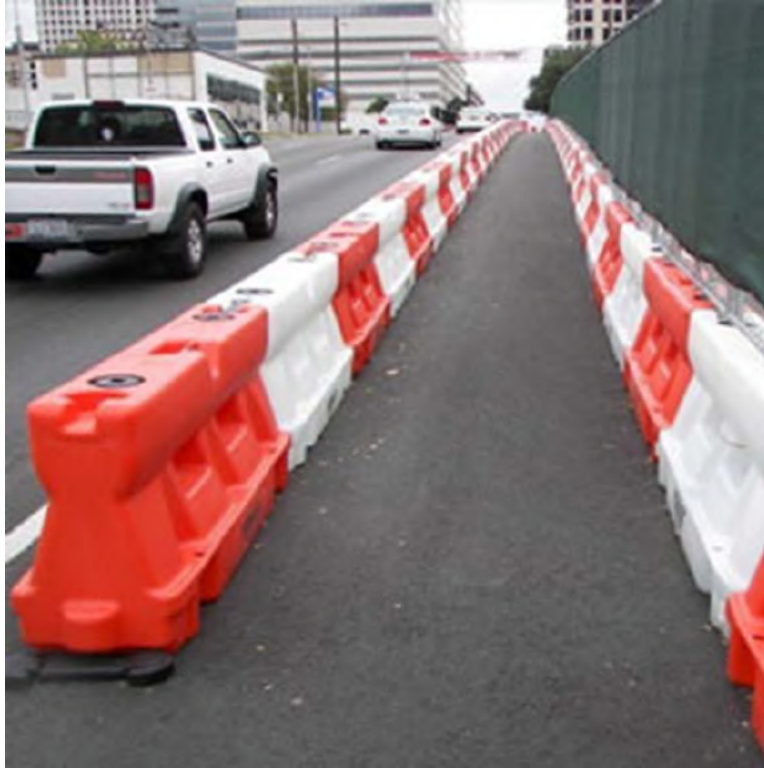
This is a quick and temporary treatment option to channel pedestrians and bicyclists through a designated low-risk path. This can be especially useful at LRT pedestrian crossings during large city events such as a game day. This is a popular low cost way for cities to temporarily control and restrict vehicle, pedestrian, or bicycle movements. No additional information or data on its efficacy.

**Figure 5.35: Temporary Curb, (N/A, N/A)**
